Documenting the Rate of Carving Loss Due to Natural Processes in the Totem Poles of Nan Sdins using Image Analysis – 1982 to 2009

Clifford Cook, David W. Grattan, James Hay and Andrew Todd

Journal of the Canadian Association for Conservation (J.CAC), Volume 38
© Canadian Association for Conservation, 2013

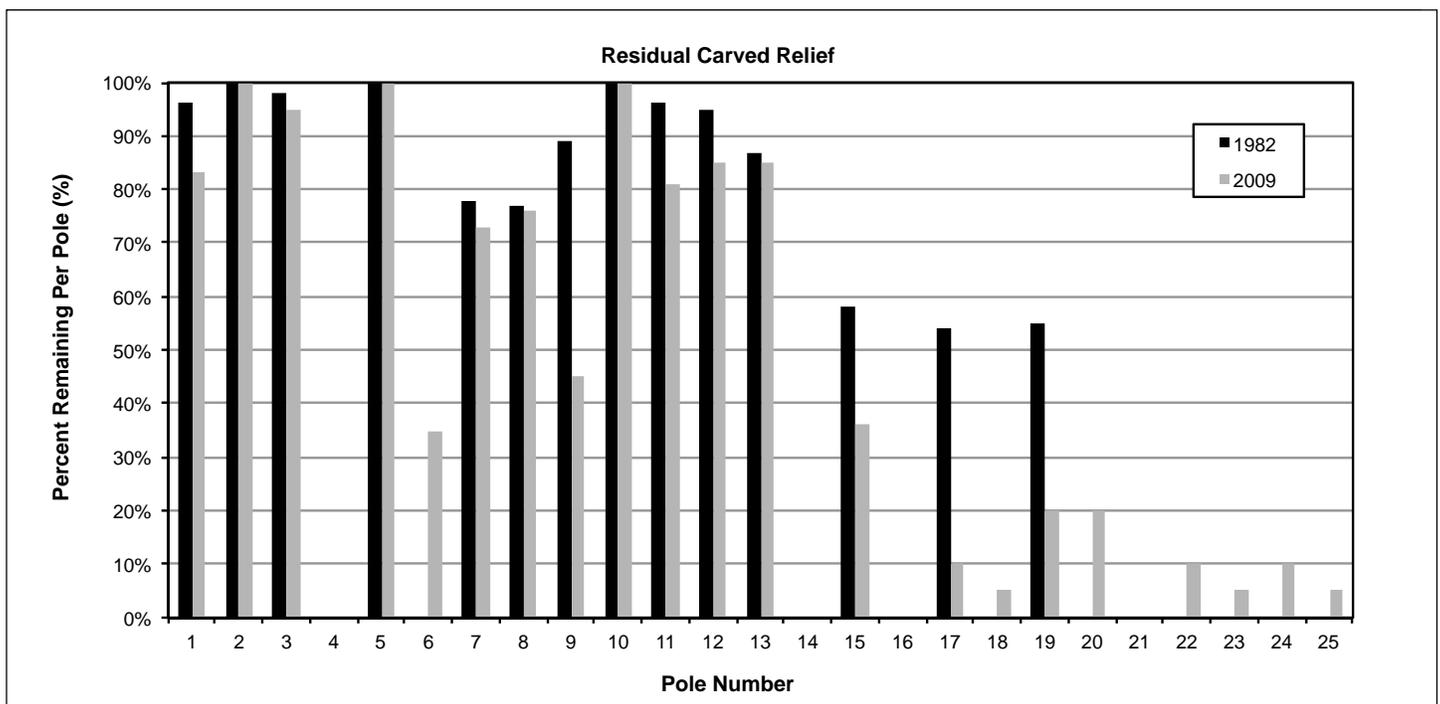
The percent residual carved relief in 1982 and 2009 is compared for each pole in **Figure 1** and **Table I**. Three of the poles (2, 5 and 10) have suffered no surface losses and still retain 100% of the carved features. All of the others for which carved areas were documented in 1982 show an increased loss of carved image since then. We present in detail below the results from two poles, poles 1 and 9, which exemplify some of the trends. Note that some poles are missing entirely because they have fallen over and have little or no image remaining. It should also be noted that poles 21, 23 and 25 show evidence of being burnt in an 1892 fire;⁷ as a result, the little remaining image was not documented in 1982.

The data in **Table I** show that in 2009 one third of the poles still retain more than 80% of their carved relief, only one fewer than did so in 1982. Altogether the surviving poles preserve about 44% of their original surface carved relief, an overall loss of about 5% of carved relief since 1982. Generally speaking, there is a noticeable decrease in the quality of preservation going from the north (pole 1) to the south (pole 25) of the site. This shows up well in the plot shown in **Figure 1**. A comprehensive report⁸ on the 2009 re-evaluation compared loss analysis results with original 1982 data for each pole.

Figure 1. Comparison of percent residual original surface (i.e. carved relief) for 1982 and 2009 by pole number going from north to south across the site.

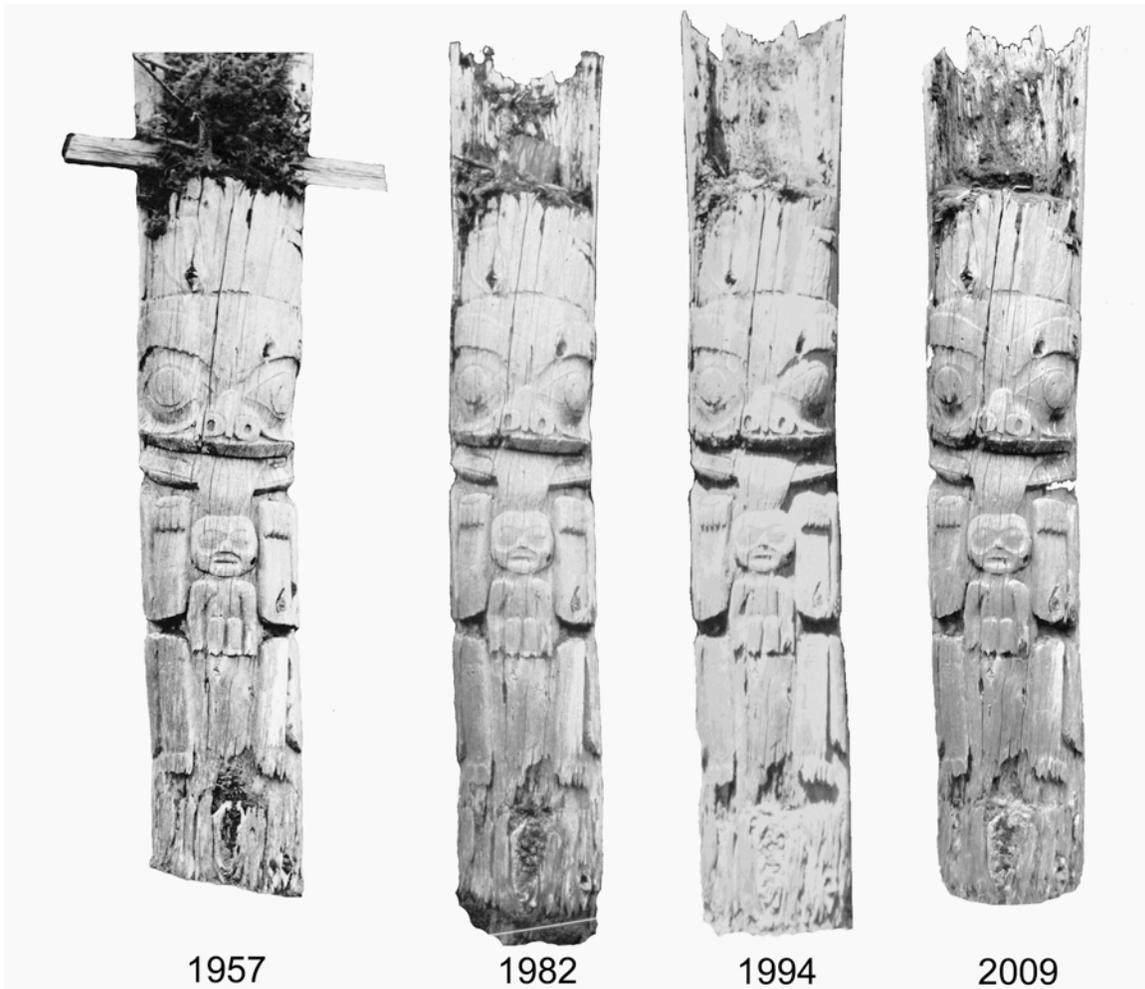
Pole 1 had changed very little in overall appearance since 1982 and still looked much like it did in 1957, as is clear from the comparison shown in **Figure 2**. Note, however, that after 1957 the last frontal board was lost and by 1994 the coffin box in the recess at the top of the pole had disappeared. The slow rate of surface change correlates well with the observations made in 1982 which showed little bulk degradation of the lower portion of this pole. **Figure 3** shows the radiographic wood density at 5 and 22 cm above the ground as measured in 1982. Note the close correlation between measured wood density (continuous line) and normal density of western redcedar (0.34 g/cc, dashed line). 6J Pilodyn data (**Figure 4**) indicated that the density of the superficial wood at about 20-30 cm above ground was between 0.30 g/cc and 0.36 g/cc – within the range of the normal density for western redcedar.

Figure 2. The changing appearance of pole 1 from 1957 to 2009. Notice the loss of the coffin box between 1982 and 1994. Image from 1994 photograph courtesy of Gwaii Haanas/Parks Canada. Image from 1957 photograph, PN07672, courtesy of Royal BC Museum, BC Archives. Images have been cropped from the original photographs.

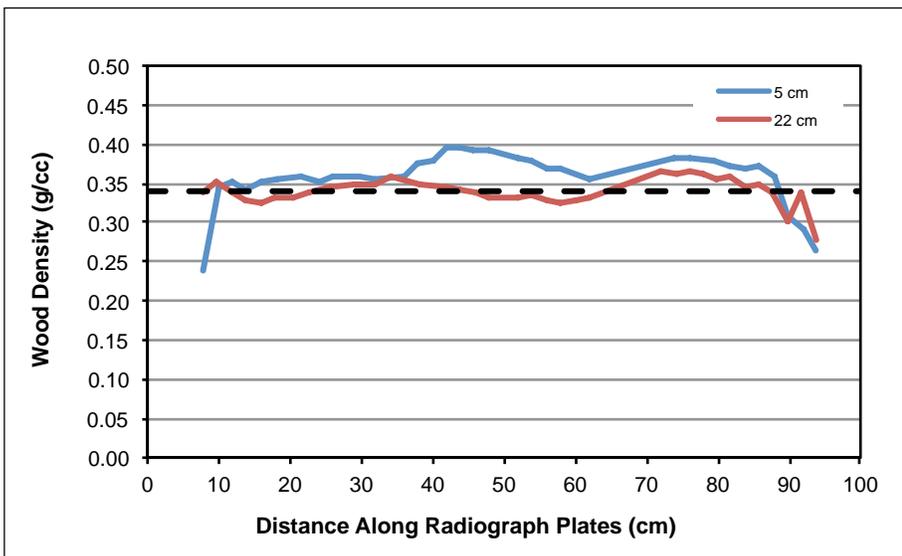
Figure 3. Radiographic wood density of pole 1 at 5 and 22 cm above the ground in 1982. The dashed line is the normal density of western redcedar.

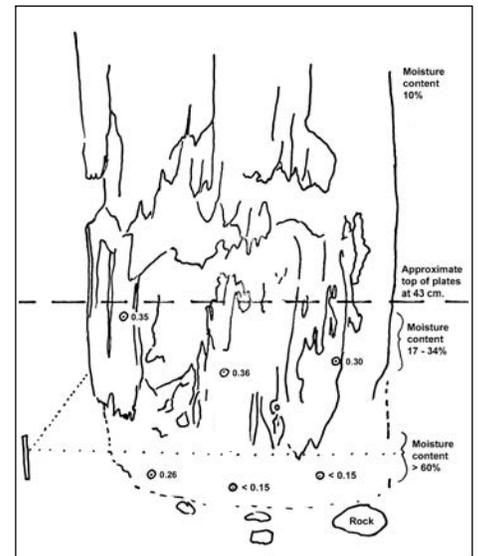
Figure 4. Pilodyn measurements of the front of pole 1 at the base in 1982.

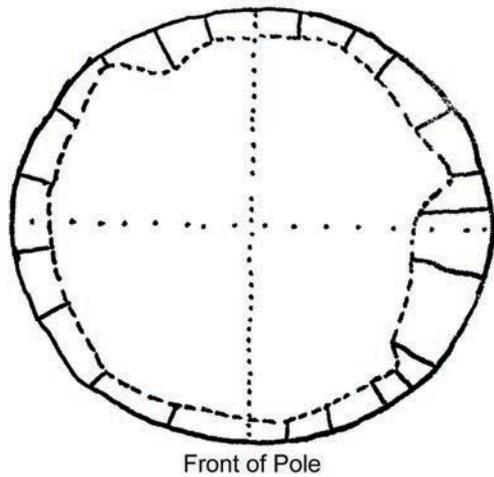
At ground level, the values are somewhat less as a result of deterioration. In addition, the probing results around the base of the pole (**Figure 5**) showed comparatively little loss of cross section to rot.

Figure 5. Apparent sound cross section (inside dashed line) at the base of pole 1 as measured by probing at ground level in 1982. The diagram shows that 71% of the total cross section of the pole was remaining.

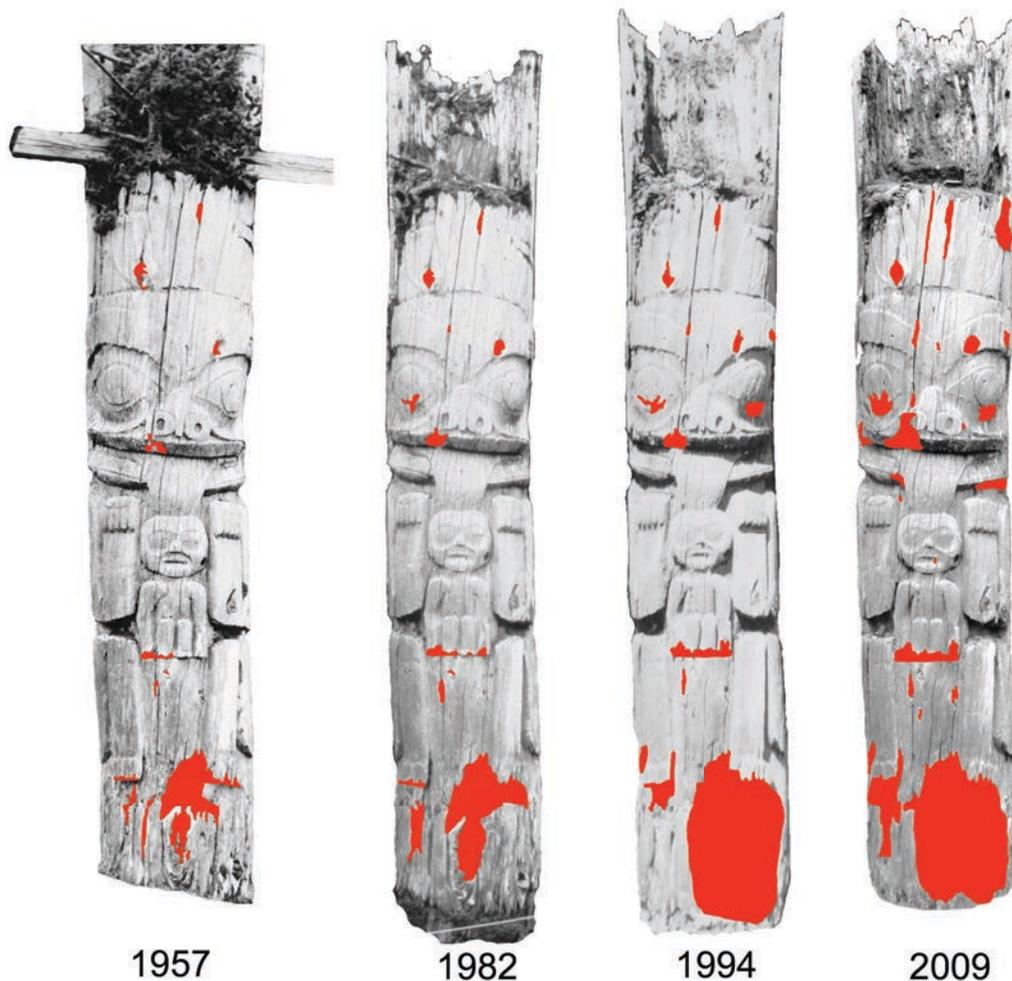
When the surface of Pole 1 was re-examined closely in 2009, however, it became clear that significant changes had taken place and that the appearance of little deterioration or of stability will likely soon change. The pole appeared seriously rotted below a white/light grey shell on the surface. In some areas the sound surface zone was perilously thin and had an almost lace-like quality. While surface losses are generally small, crack propagation and the growth of pockets of rot are evident. These changes become more prominent when the surface losses are marked in red (**Figure 6**) and the progression from 96% to 83% carved image remaining can be seen.

Figure 6. Carved relief loss in pole 1 from 1957 to 2009 marked in red on corrected images. Image from 1994 photograph courtesy of Gwaii Haanas/Parks Canada. Image from 1957 photograph, PN07672, courtesy of Royal BC Museum, BC Archives. Images have been cropped from the original photographs.

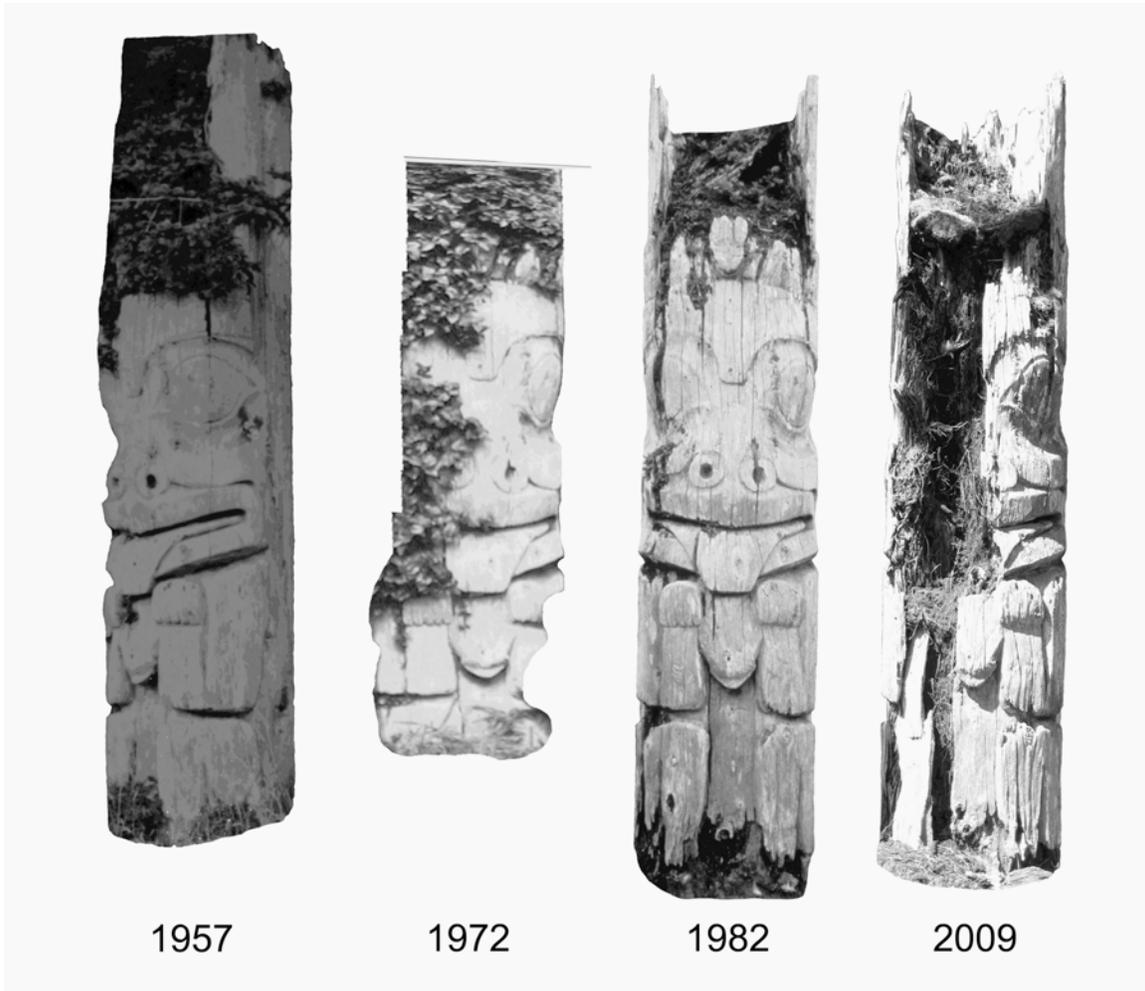
Pole 9 provides an interesting example of extreme deterioration (**Figure 7**). The data accumulated in 1982, which are shown in **Figures 8 and 9**, clearly indicated that the left (right proper) side of the pole was seriously deteriorated, although perhaps not so much at ground level. Moving up the pole from a height of 5 cm to 39 cm, the radiographically derived density – shown as the continuous lines in **Figure 8** – diverged from the normal western redcedar density of 0.34 (the dashed line) on the left side of the graph. Nevertheless, little surface damage was evident in 1982 (**Figure 7**). However, as the photograph taken in 2009 shows, major losses on the left side, including substantial surface carving, have exposed the inner deterioration indicated radiographically in 1982.

Figure 7. Pole 9 from 1957 to 2009. Images from 1957 and 1972 photographs courtesy of Gwaii Haanas/ Parks Canada.

evidence of massive root invasion and humus formation (**Figures 7 and 10**). The debris from the pole was lying on the ground which would suggest that this loss was not a result of vandalism.

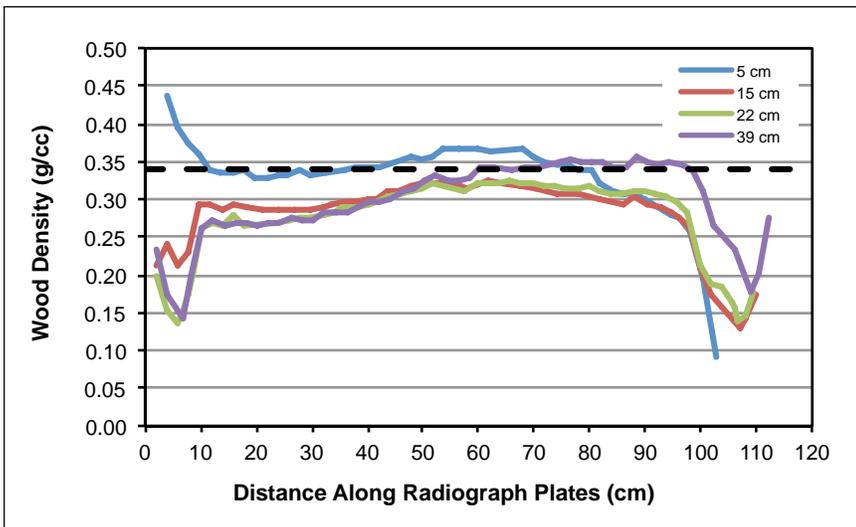
Figure 8. Radiographic wood density of pole 9 at 5, 15, 22 and 39 cm above the ground in 1982. The dashed line is the normal density of western redcedar.

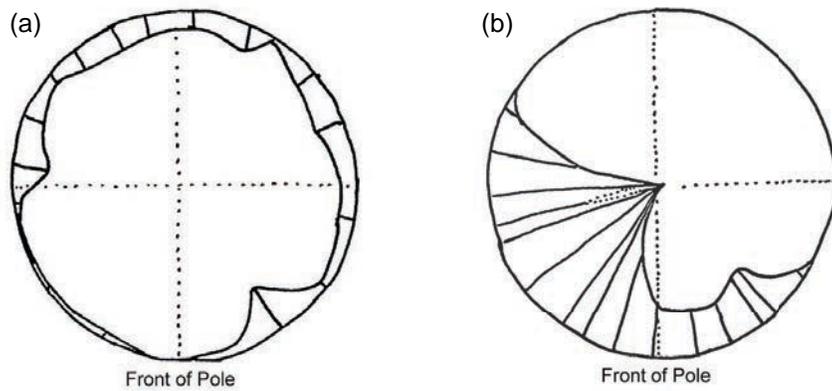
Figure 9. Apparent sound cross section (inside dashed line) of pole 9 at (a) ground level and at (b) 30 cm above ground level as measured by probing in 1982. The diagram shows the extent of loss higher in the pole: 83% of the total cross section of the pole remained at ground level but only 64% remained at 30 cm above ground level.

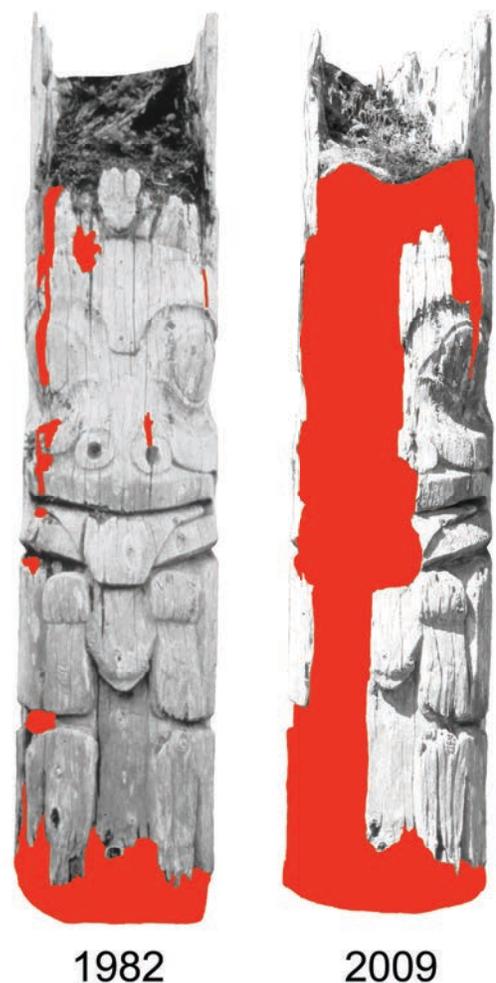
Figure 10 highlights the losses that occurred between 1982 and 2009. The percent carved image remaining dropped from 89% to 45%. The source of these losses is abundantly clear: extensive interior rot likely augmented by the presence of a massive root system from a tree that grew on the top of the pole. As with many of the poles, vegetation grew in the

coffin recess at the top and in this case pushed its root system down through the pole. The roots undermined and dislodged the surface on the right proper side. Although the quality of the earlier images (pre 1982 in **Figure 7**) is very poor, making precision difficult, it does appear that very little if any rot had shown itself on the surface of the pole before 1982. This is also a good example of how changes in the appearance of poles can be sudden and catastrophic.

Figure 10. Pole 9 in 1982 and 2009 with the losses indicated in red.

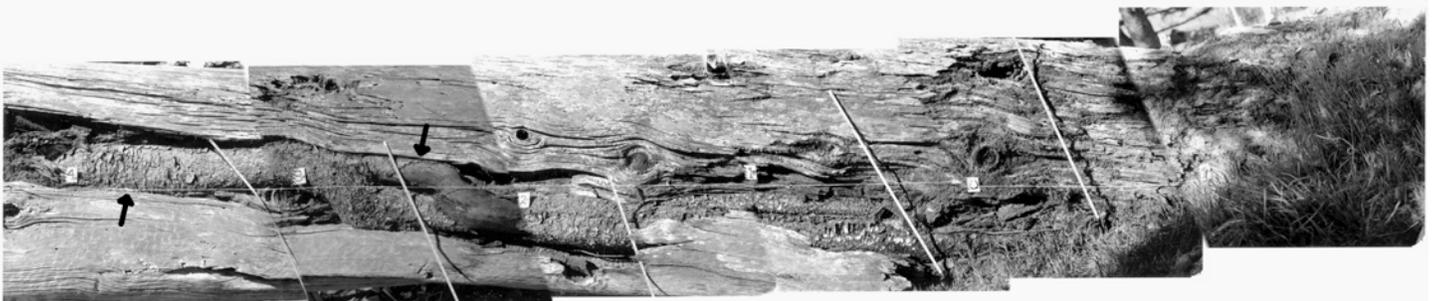
Deterioration is also influenced by mosses and vegetation that grow on the exterior of poles. The mosses do not attack the wood but retain surface moisture and provide areas where other plants can take root. Vegetation, such as trees and bushes, sends roots into the interior of the poles and causes extensive damage by splitting the pole or causing larger pieces to slough off. In other cases, the growth of leafy branches provides something which acts like a sail and the wind pressure resulting causes the pole to be blown over. Pole 17 shown in **Figure 11** is a classic example. The pole had blown over before 1982 and, by 2009, has lost nearly all its carved relief; yet still embedded was a massive parasitic root.

Figure 11. A photo montage of fallen pole 17 in 1982 showing the tree root extending along the length of the pole (the base of the pole is to the right).

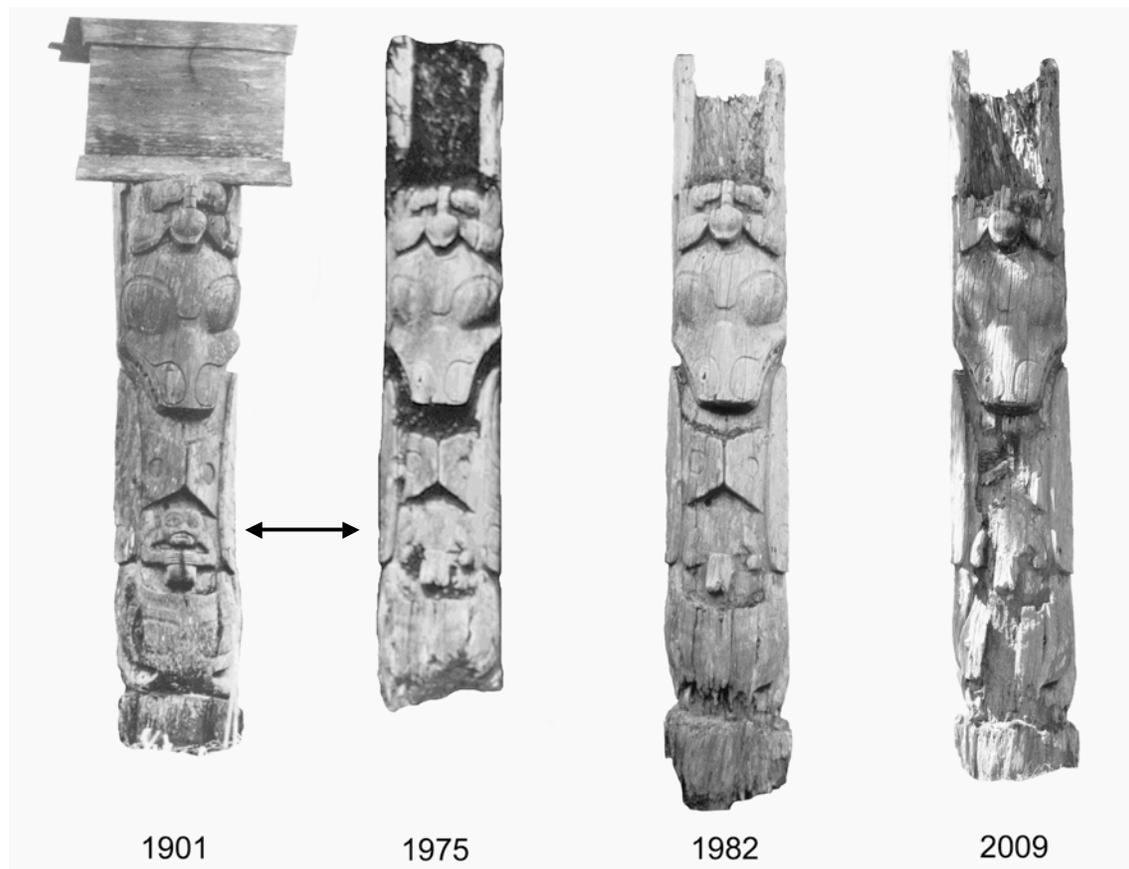
Vandalism can also cause damage but there was no direct evidence that this caused any of the damage observed in this study. However, the images of pole 11 in **Figure 12** show the loss of a face near the bottom sometime before 1975 and in **Figure 2**, the coffin box at the top of pole 1 was not there after 1982. These could be considered as possible examples of unsanctioned removal of material.

Figure 12. Changes in pole 11 from 1901 to 2009 including losses that might be attributed to vandalism. Image from 1975 photograph courtesy of Gwaii Haanas/Parks Canada. Image from 1901 photograph, PN07781, courtesy of Royal BC Museum, BC Archives. Images have been cropped from the original photographs.
