The Re-treatment of an Inuit Beaded Skin Parka

Heather Dumka

Glenbow Museum, 130-9th Avenue S.E., Calgary, Alberta T2G 0P3, Canada; hdumka@glenbow.org

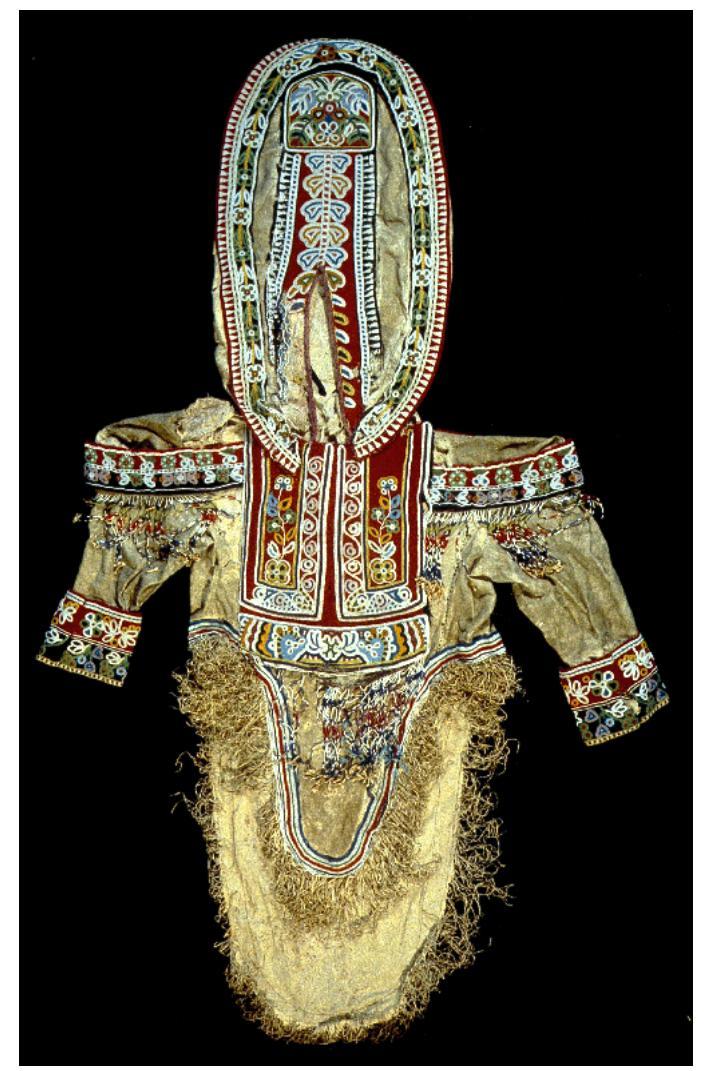
Figure 2. Condition of parka when acquired in 1961, with all of the panels laid in place. Photograph by Joe Rosettis, courtesy of the Glenbow Museum, Calgary, Alberta.

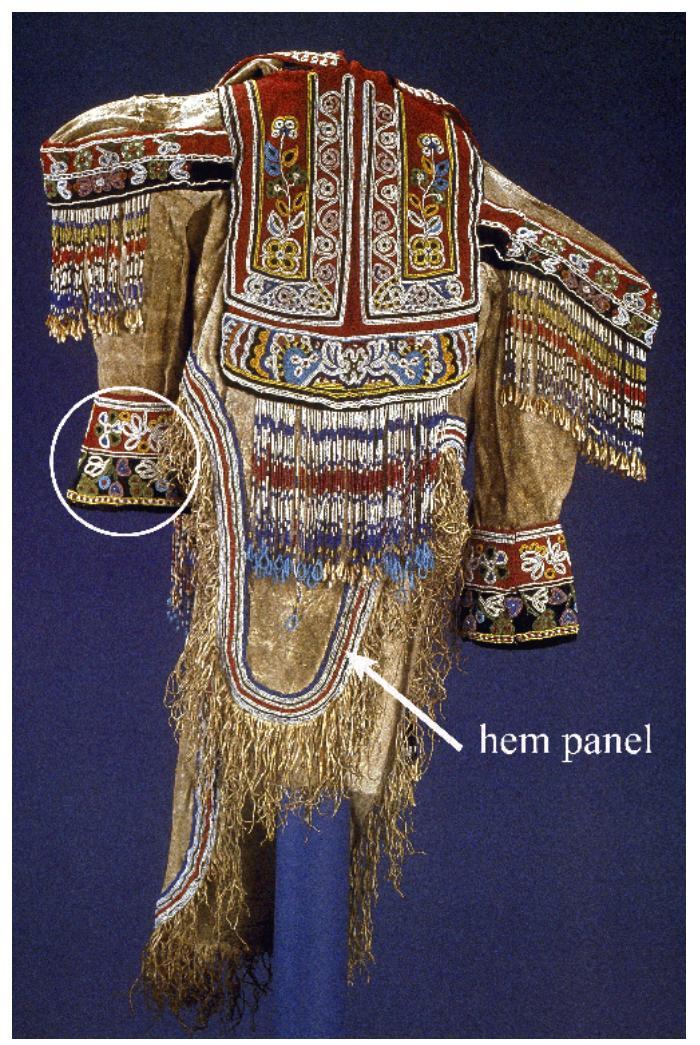
Figure 3. Parka displayed on a mannequin after being restored in 1967. The hem panel was not restored at this time. The tapering wrist panels have been attached so that they flare outwards from the sleeves. Compare the wrist panel with the orientation of the same panel in Figure 1: the top edge of the panel in Figure 1 is at the bottom of the sleeve in Figure 3. Photograph by Glenbow photographer, courtesy of the Glenbow Museum, Calgary, Alberta.

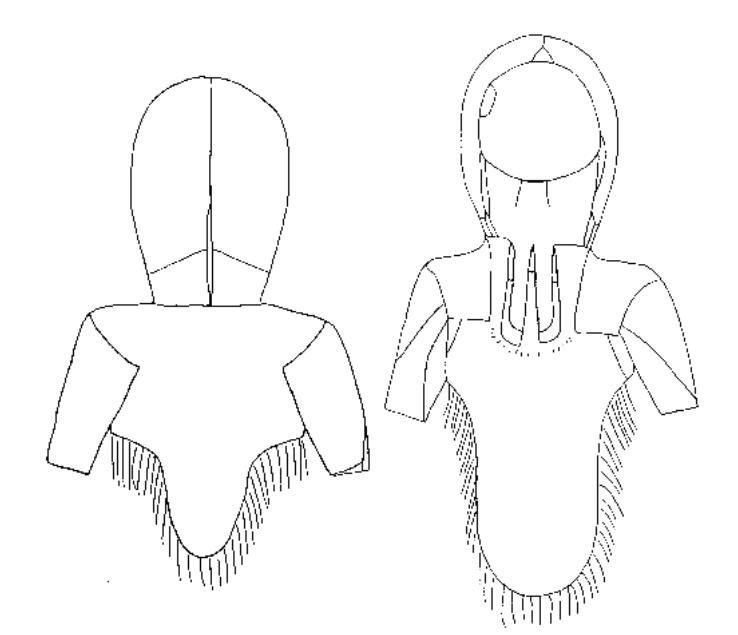
Figure 4. Diagram showing the skin pieces making up the parka front (left) and back (right). Drawing by Heather Dumka, courtesy of the Glenbow Museum, Calgary, Alberta.

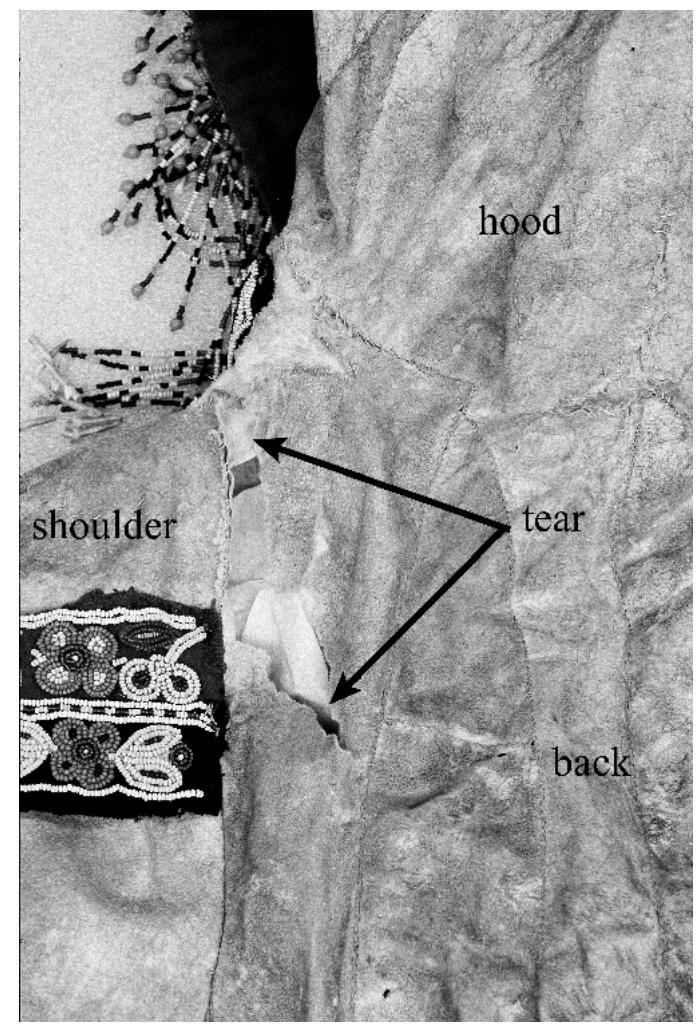
When first examined, damage to the parka was evident from tears visible in the back of the hood, shoulders and neck (Figure 5), and skin patches in the shoulder area and inside the hood. The full extent of the damage was difficult to see because the beaded panels covered a large portion of the chest and shoulders. When the panels were removed, the numerous tears on the chest, shoulders and hood were found to have been whip-stitched together with a white cotton-blend thread. Smaller tears had no backing, but larger tears and holes were also stitched down onto pieces of oil-tanned or brain-tanned leather. These patches were much thicker than the original caribou skin, which is almost paper thin in some areas. New tears were being caused from the stitching technique as well as from the weight of the patches and the beaded panels. The chest had a network of tears with losses at both shoulders and had been stitched down to a very large leather patch that extended from the neck to the top of the flap. One large, detached piece of skin below the front of the neck had been incorrectly placed during the restoration, spreading apart the upper chest. The neck edge on the front section of the parka had also been displaced downwards (Figure 6). As well as increasing the width of the chest, the repair had caused the pouched shoulders to lie flat instead of angling forward as is typical with this style of parka.¹¹ This likely also caused the uneven shoulders and twisting of the parka as seen in the photograph on the mannequin. The restorer who carried out this earlier repair probably would have been more familiar with skin clothing typical of the northern plains which is less tailored and simply drapes across the shoulders.¹²

Figure 5. Tear in the back of the left shoulder of the parka (detail, BT). Photograph by Heather Dumka, courtesy of the Glenbow Museum, Calgary, Alberta.

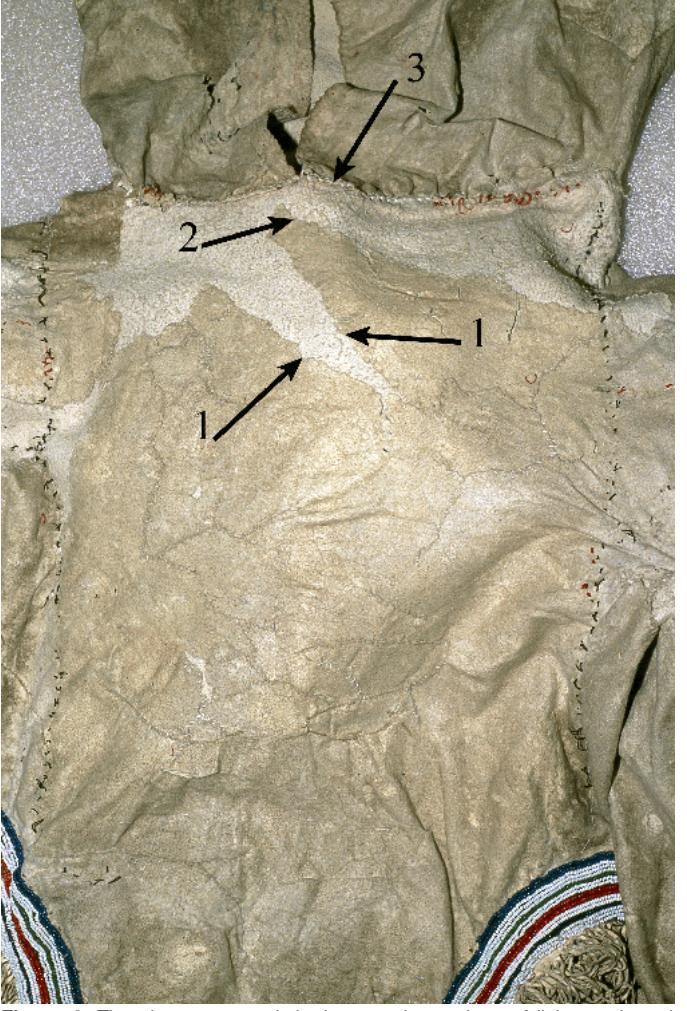
Figure 6. The chest area stitched onto a large piece of lighter coloured leather (detail, BT). The torn skin edges (1) were spread apart in the 1967 restoration. The upper edge of the skin on the chest (2) was also displaced downwards from the neck seam (3). Photograph by Heather Dumka, courtesy of the Glenbow Museum, Calgary, Alberta.

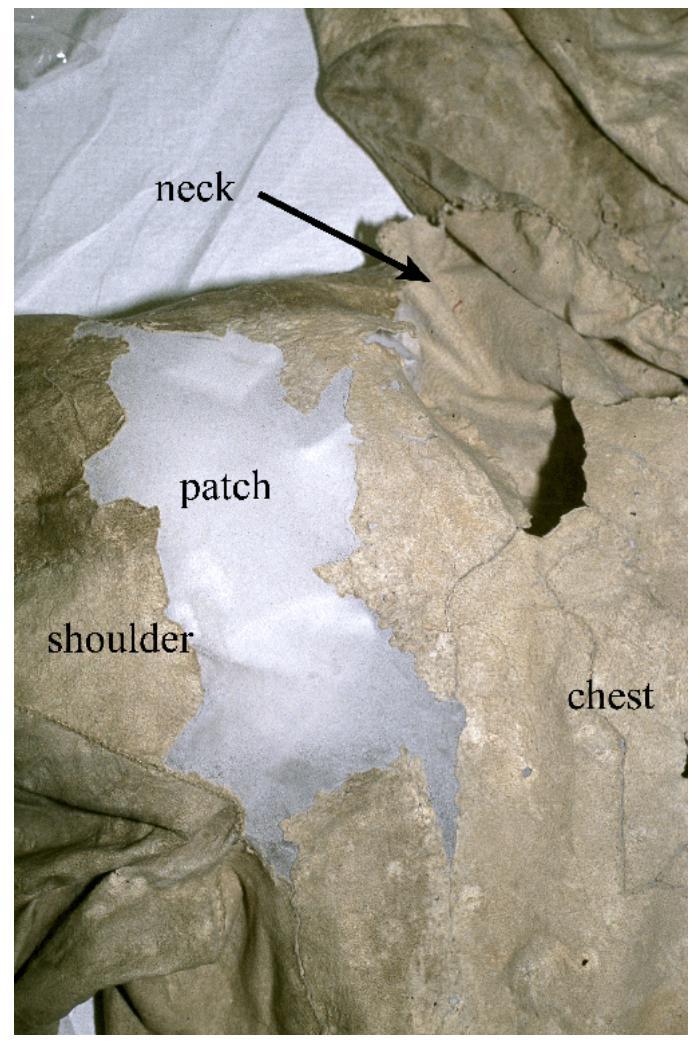
Figure 7. Cerex patch on the right shoulder (exterior view). Photograph by Heather Dumka, courtesy of the Glenbow Museum, Calgary, Alberta.

A few of the patched losses were visible after the panels were replaced, especially the one on the right shoulder. These were toned to match the colour of the surrounding skin using Liquitex acrylic paints. The paint was applied over the BEVA that was on the surface of the Cerex patch. While visible, the patches are not obtrusive and do not detract from the overall appearance of the parka. A benefit of using the Cerex is that the fabric is thin enough that it does not obscure the underlying skin; without close inspection, the visible portions of the back flap do not appear to be lined, although the white colour of the fabric makes the skin look slightly lighter in colour than the unlined skin (**Figure 10**).

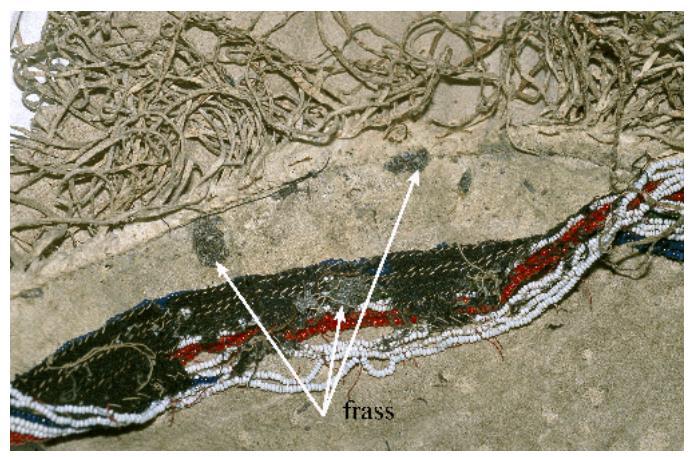
Figure 8. Insect frass found under the damaged beaded hem panel. Photograph by Heather Dumka, courtesy of the Glenbow Museum, Calgary, Alberta.

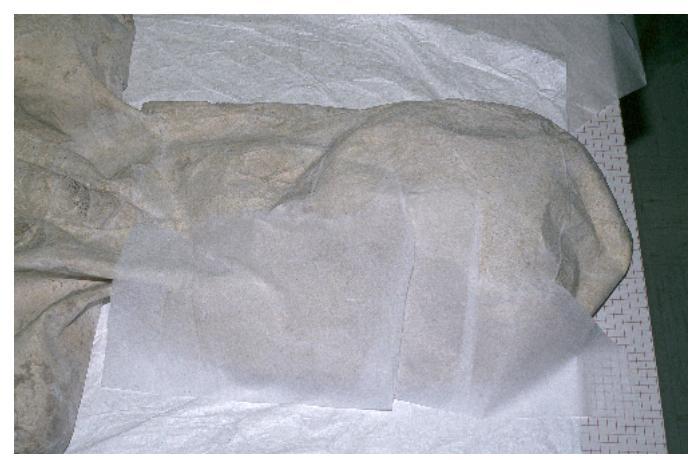
Figure 9. The Cerex lining is slit and overlapped to fit the contours of the hood. Photograph by Heather Dumka, courtesy of the Glenbow Museum, Calgary, Alberta.

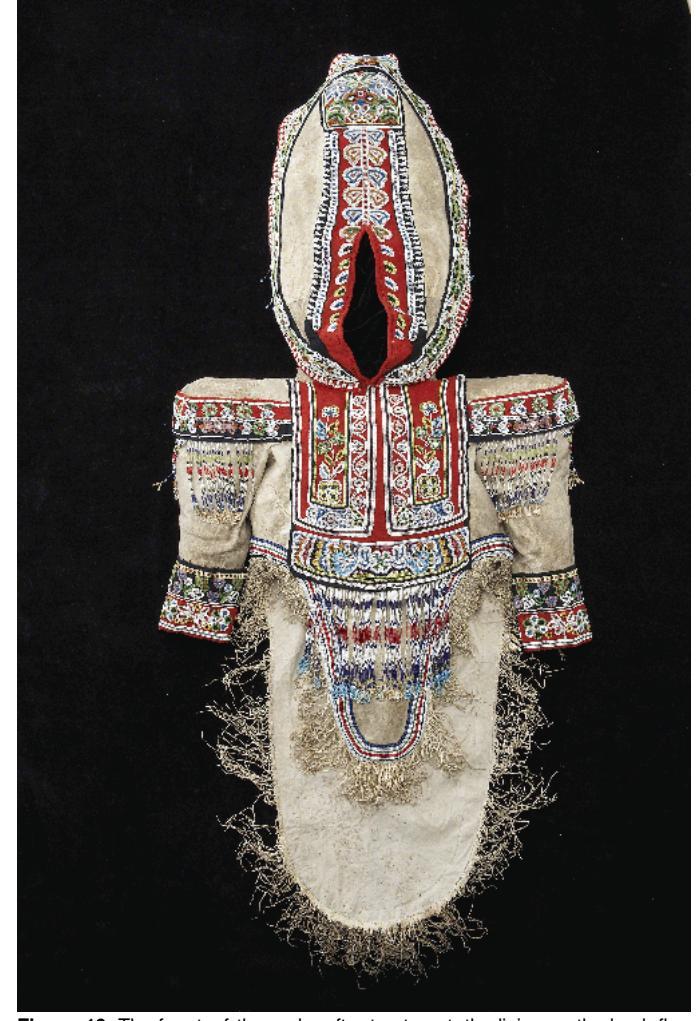
Figure 10. The front of the parka after treatment; the lining on the back flap does not obscure the underlying skin. Photograph by Owen Melenka, courtesy of the Glenbow Museum, Calgary, Alberta.

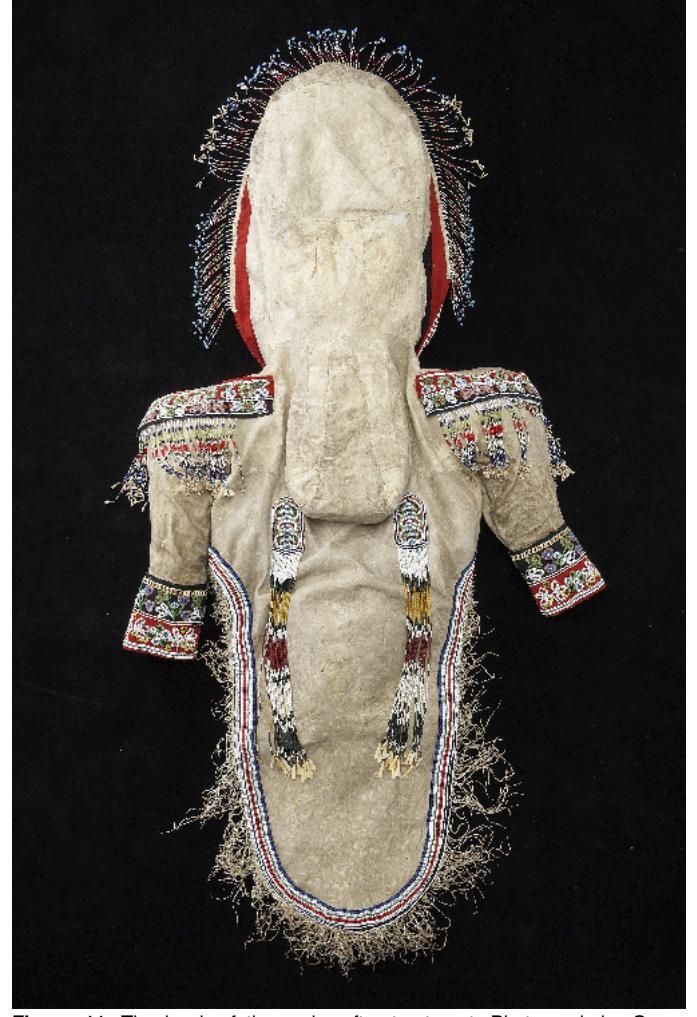
Figure 11. The back of the parka after treatment. Photograph by Owen Melenka, courtesy of the Glenbow Museum, Calgary, Alberta.
