# Issues Relating to the Conservation of a 19th-Century Swell-body Sleigh

Sue Warren

Journal of the Canadian Association for Conservation (J. CAC), Volume 31  
© Canadian Association for Conservation, 2007

Canada Science and Technology Museum, 1867 St. Laurent Blvd., P.O. Box 9724, Station T, Ottawa, Ontario K1G 5A3, Canada; swarren@technomuses.ca

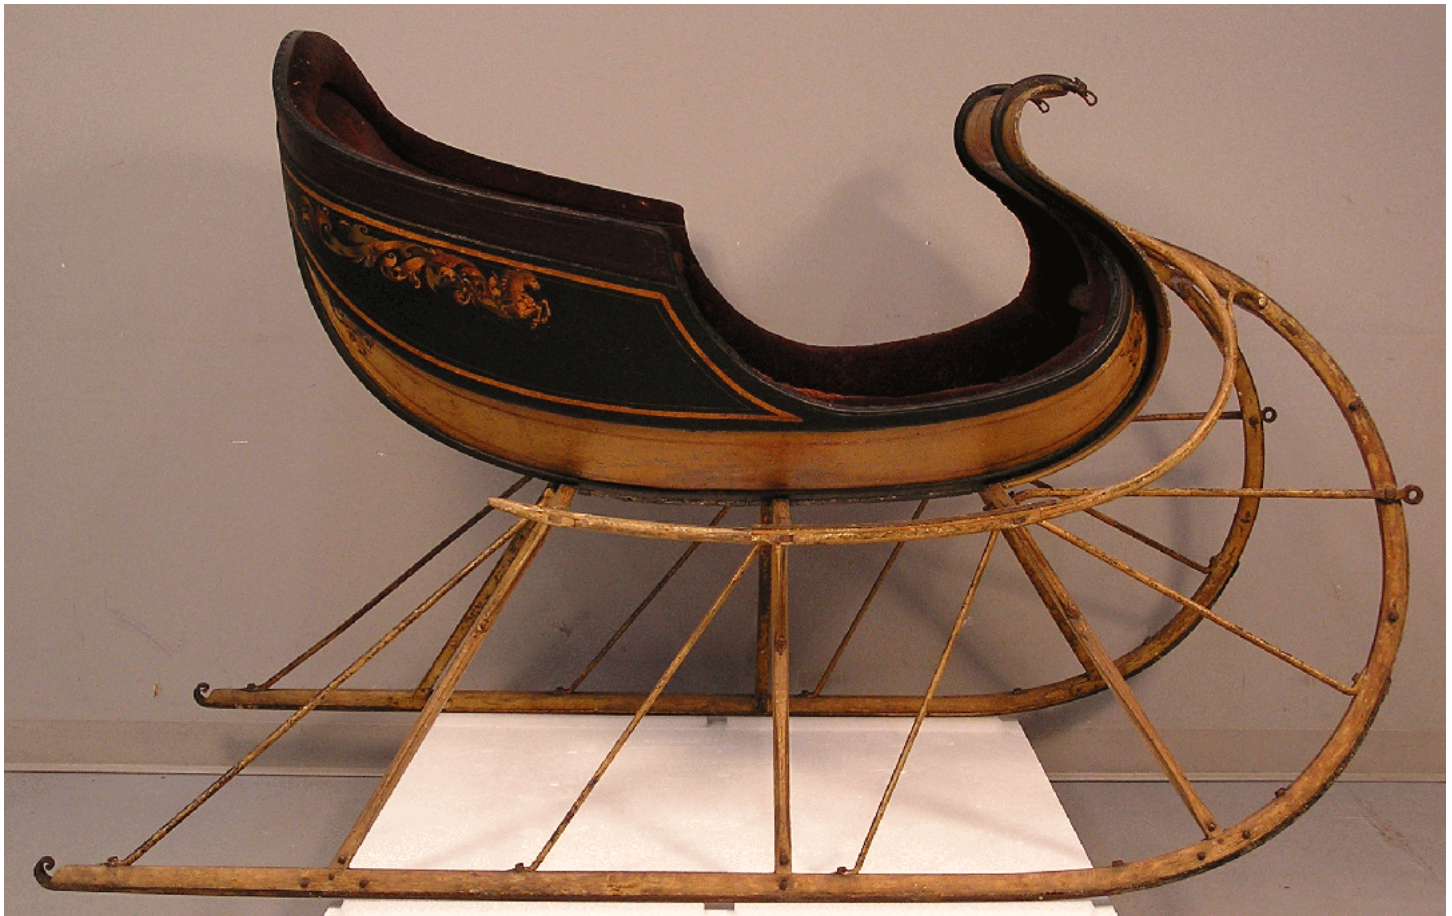
**Figure 1.** Sleigh after treatment. Photograph courtesy of the Canada Science & Technology Museum.

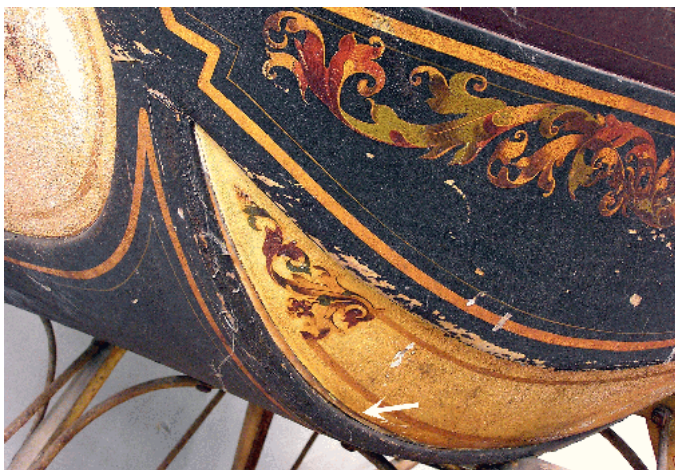
**Figure 2.** Gaps at the edges of the lower “floating panel”, illustrating the extent of wood movement following fumigation and exposure to the low relative humidity in storage. Photograph courtesy of the Canada Science & Technology Museum.

The wood movement due to humidity changes after acquisition (as described previously above) did increase the cupping, tenting and rate of paint loss; so treatment to consolidate the paint layers in the most fragile areas was undertaken immediately after fumigation. Due to the differences in condition of the various painted surfaces, different elements were treated separately and in their entirety; for example the gear was cleaned and consolidated prior to work on the body panels, and the upper panels were completed prior to consolidating the lower panels. The procedure for each area was essentially the same, though with some adaptation, as required. The order of the treatment was determined by the fragility of the paint layer and the need to stabilize those elements most at risk of irreversible damage.

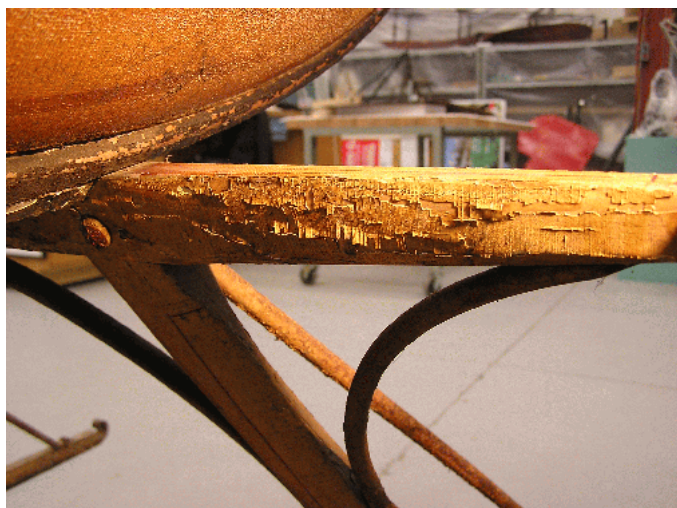
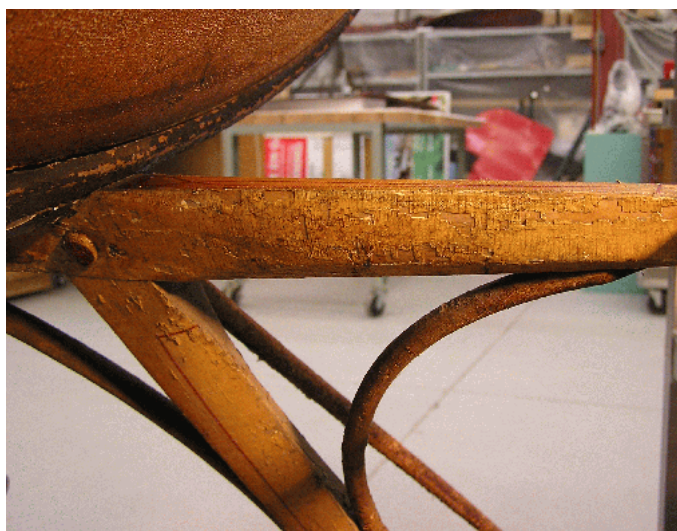
Paint on the wooden gear was curling and flaking in large fragments, while body paint and varnish was crumbling and tenting on a much finer scale. The method which worked best on the curling paint flakes of the gear, was to wick BEVA 371 (Original Formula), diluted to a thin consistency with toluene, behind the flakes, and gently lay them flat with a warm tacking iron. BEVA 371 (Original Formula) was used in all consolidation treatments on the sleigh, and was diluted to the consistency required depending on the specific problem: for example, with smaller paint flakes and tenting, a more dilute adhesive was required to penetrate behind paint flakes. Larger paint chips needed a thicker adhesive.

**Figure 3.** Curling paint flakes on wooden gear elements, (a) before and (b) after treatment. Photographs courtesy of the Canada Science & Technology Museum.

Excess BEVA was removed before it had completely dried, by swabbing with isopropanol. Isopropanol was preferred over toluene for this process due to its decreased likelihood of dislodging the consolidated flakes of paint. The disfigured varnish layer was still in place at this point, so the isopropanol did not contact the original paint layer. **Figure 3** illustrates the process on the wooden runner structure.

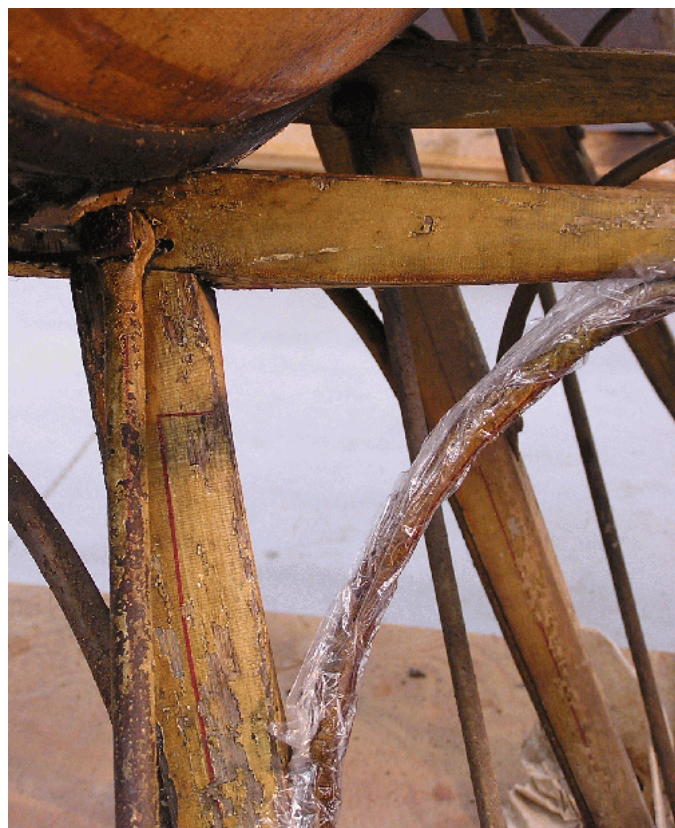
As is often the case, corrosion of the iron-work had caused discolouration and loss of paint on all of the gear. Most of the corrosion was inactive at the time of acquisition. The paint that remained was secure, but rust-stained, and covered in layers of barn debris. Once the water-soluble grime had been removed from the gear by washing with Orvus WA Paste and deionised water and rinsing, the iron-stained paint was cleaned by applying a gel poultice of 5% citric acid in methyl cellulose. The gel poultice was covered with clear food wrap to contain it, to slow the drying, and also to ensure that the gel had a good contact with the entire surface, as maintaining long-term wet contact is necessary to ensure that the stain is drawn out. If the treatment was not completely successful after one application, the area was treated a second time, with the gel never remaining on the surface for longer than 20 minutes at each application. The surface was rinsed with deionised water after treatment, and the varnish cleaned with swabs and ethanol (**Figure 4**).

**Figure 4.** Painted iron component during cleaning with a poultice of 5% citric acid in methyl cellulose. Photograph courtesy of the Canada Science & Technology Museum.

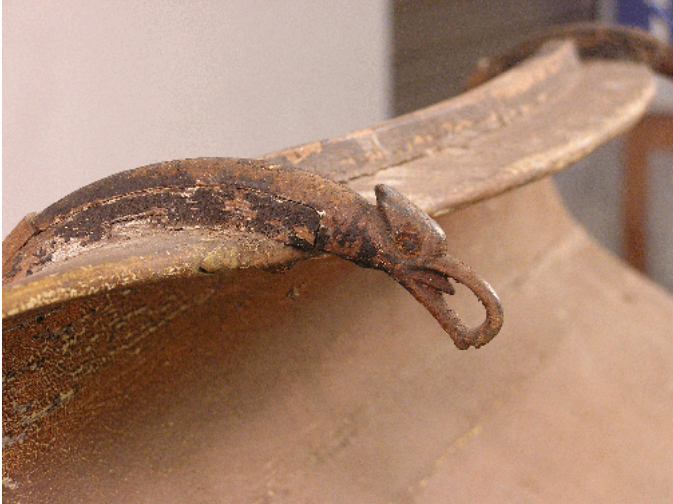
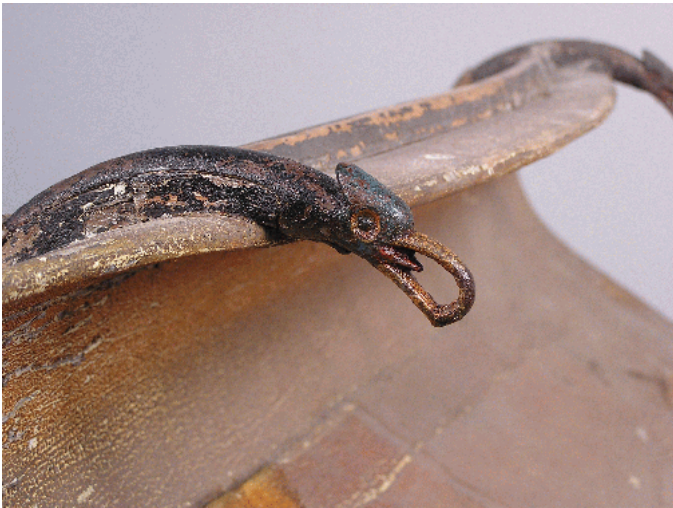
**Figure 5.** Eagle head detail on dash, (a) before and (b) after cleaning and removal of darkened varnish. Photographs courtesy of the Canada Science & Technology Museum.

varnish removal so that a uniform appearance could be achieved slowly. Pure ethanol was aggressive and in test spots was difficult to control. Visible differences after treatment were most noticeable in areas such as the decorative eagle heads on the dash, where surprising colour details were revealed (**Figure 5**).

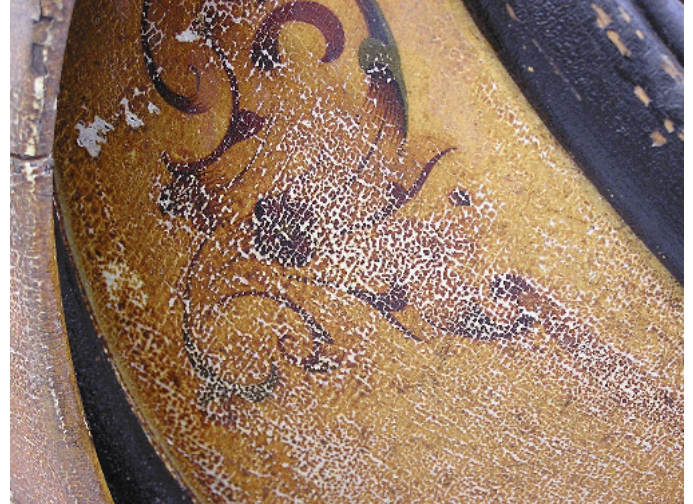
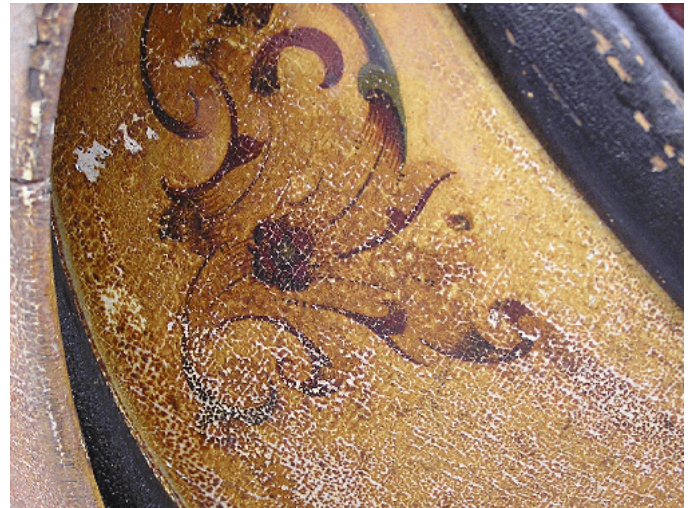
**Figure 6.** Detail of decal, (a) before and (b) after consolidation. Photographs courtesy of the Canada Science & Technology Museum.

Varnish reduction was not undertaken on light coloured body panels with decals (lower and back), since the decals were so intrinsically bonded with the varnish that they had reticulated with it. Over time the layers become indistinguishable, and the solvents that will remove discoloured varnish from the surface can also dissolve the bond between decal and underlying paint or solubilise the decal.

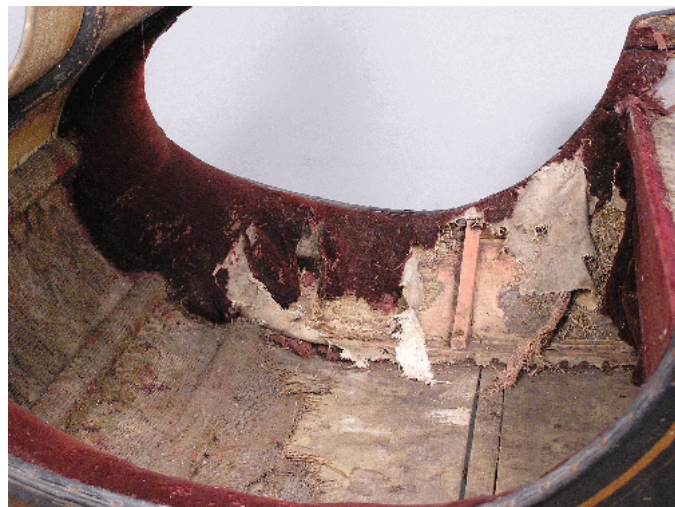
**Figure 9.** Carpet and plush fabric body-liner before treatment, showing damage from mouse infestation. Photograph courtesy of the Canada Science & Technology Museum.

The carpet, made of a coarse woven burlap fabric with looped pile, was severely worn and embrittled. Almost all of the original material from the centre of the footwell was missing due to the previous cleaning, but the remaining fabric was firmly held in place by tacks. As is invariably the case, the fibres of the carpet were severely abraded by grit and debris deposited throughout a lifetime of use. Treatment of the carpet involved removal of tacks

on the lower section in order to lift the fabric and clean underneath. It was also wet-cleaned in-situ by sponging a solution of 1% Orvus in deionised water through the fibres onto a pad of blotting paper. After cleaning, the verso of the carpet was backed with Reemay and BEVA 371 Film, applied with a hot air gun to ensure complete support of the warp and weft threads. A thin border of Nylon Gossamer and BEVA Film was applied around the fragile edges, and wrapped over onto the recto to prevent the ends of the carpet fibres from being further damaged.

Losses to the plush body-liner fabric were replaced using a mohair plush fabric of similar weight and colour.<sup>11</sup> The replacement fabric used was a close approximation of the original, but variances in colour and pile height result in a visible difference. The new fabric was toned down slightly by rubbing in a very dilute acrylic paint mixture to simulate age and wear. Losses in horsehair and cotton 'kapok' fibre padding were filled with carved Ethafoam blocks, covered with polyester quilting padding. This enabled the silhouette of the original to be reproduced, and minimised the visual impact of the damaged areas. **Figures 9 and 10** show the inside of the body before treatment, and after. Missing carpet was not replaced since the loss was not as visually distracting as the loss of the red plush fabric.

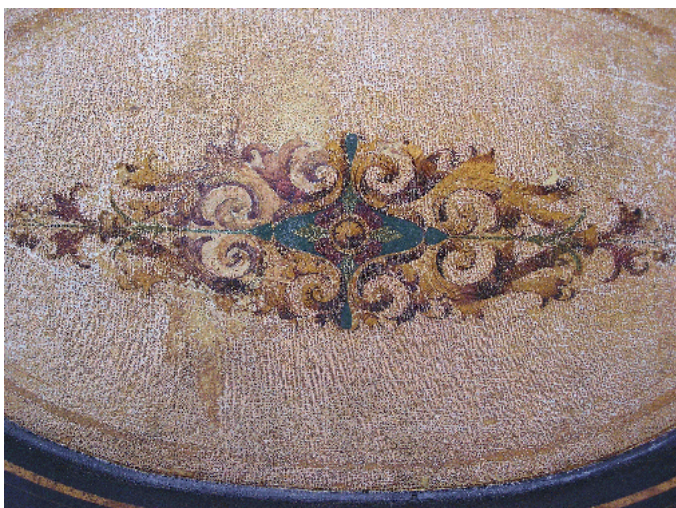
**Figure 8.** Close-up of decal on rear panel, after consolidation and some inpainting. Photograph courtesy of the Canada Science & Technology Museum.

pattern from the remaining image, and transferring it to the missing area. This was undertaken in order to reduce the very distracting impact of the damage. Inpainting was done using acrylic paints, over the B72 isolating layer. **Figure 7** shows the condition of the rear panel before treatment, and **Figure 8** shows a close-up after consolidation and some inpainting.

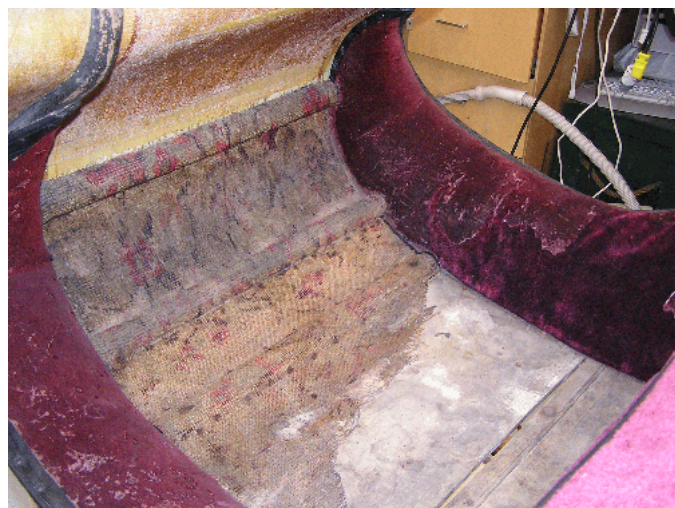
**Figure 10.** Carpet and body-liner after treatment, following cleaning and reconstruction with new padding materials and replica plush fabric. Photograph courtesy of the Canada Science & Technology Museum.
