# Performance Testing of Anti-graffiti Coatings for Painted Outdoor Murals in Canada

Michael O'Malley and Nancy E. Binnie

Journal of the Canadian Association for Conservation (J.CAC), Volume 44  
© Canadian Association for Conservation, 2019

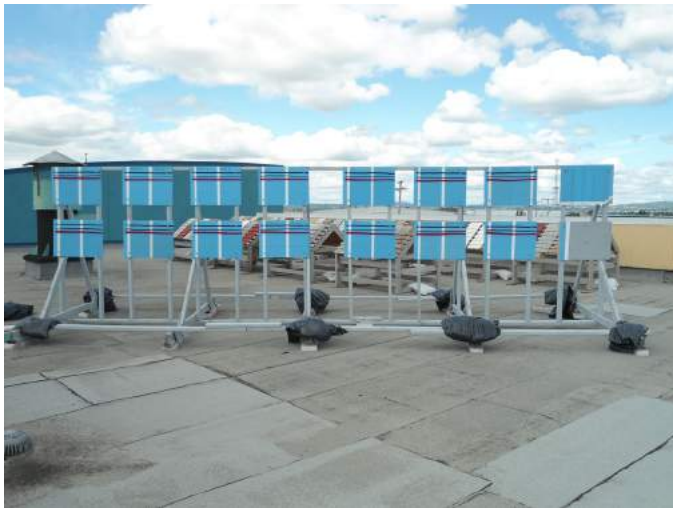
**Figure 1.** Outdoor exposure rack in 2015, before graffiti removal. Blue and white painted panels (vertical bands) have been marked with black, silver and red graffiti (horizontal markings). The unmarked, upper right sample strip panel comprises all the coatings and was used for gloss and colour measurements. The lower right Magnesiacore panel consists of two thin vertical bands of uncoated blue and white paint on a grey background.

Once prepared, the panels were photographed then placed outdoors in a vertical orientation on a rack designed and fabricated in-house for exterior weathering on the roof of the CCQ (Figure 1). The rack was installed in December 2013

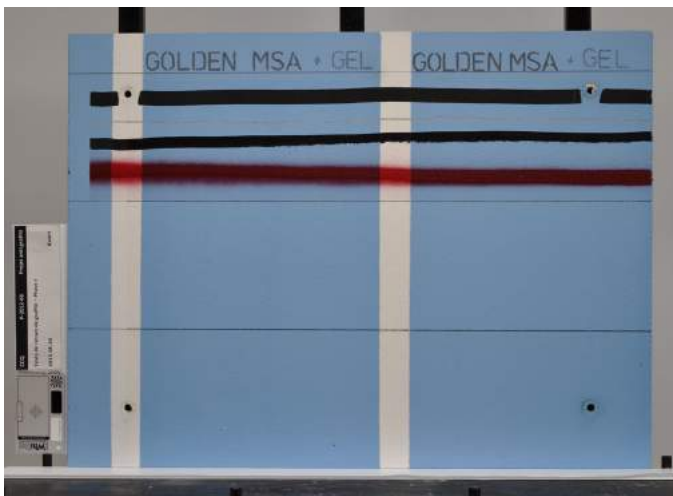
**Figure 2.** An example of a coated panel marked with applied graffiti before removal tests. Products used for graffiti markings were (from top to bottom): Montana acrylic ink marker (black), Sharpie permanent ink marker (silver), Pilot permanent ink marker (black) and Krylon Colour Master gloss spray paint (cherry red). For each panel, the first blue vertical band at left and a vertical portion of the first white band were left uncoated.

products: Sharpie permanent ink marker (silver), Montana acrylic ink marker (black), Pilot permanent ink marker (black), and Krylon Colour Master gloss spray paint (cherry red), a modified alkyd enamel. The marked panels were left to age for three to six weeks before graffiti removal trials were undertaken during the summer of 2015.

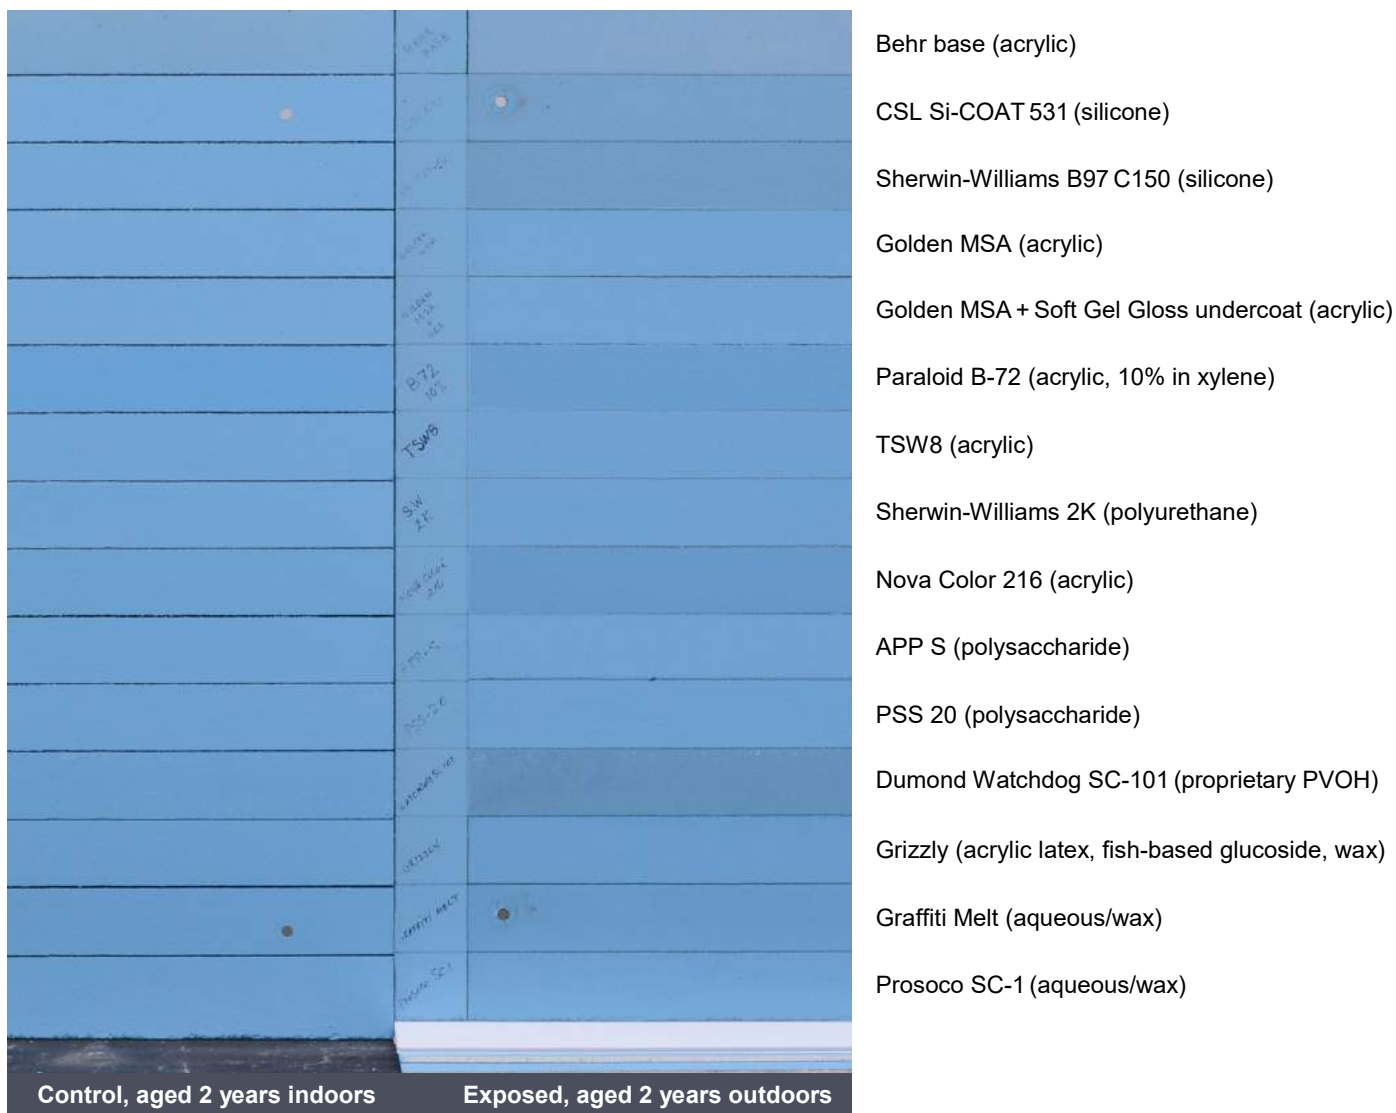
Figure 3. Comparison of the indoor control (left) and the exposed (right) sample panels viewed side by side in 2015 after two years of ageing.

After two years of ageing, a visual comparison of the two strip panels placed side by side already showed some marked differences between the aged indoor controls (**Figure 3 left**) and the aged outdoor counterparts (**Figure 3 right**). While some coatings appeared to be relatively unchanged, others had darkened and taken on warmer or cooler tones from outdoor exposure.

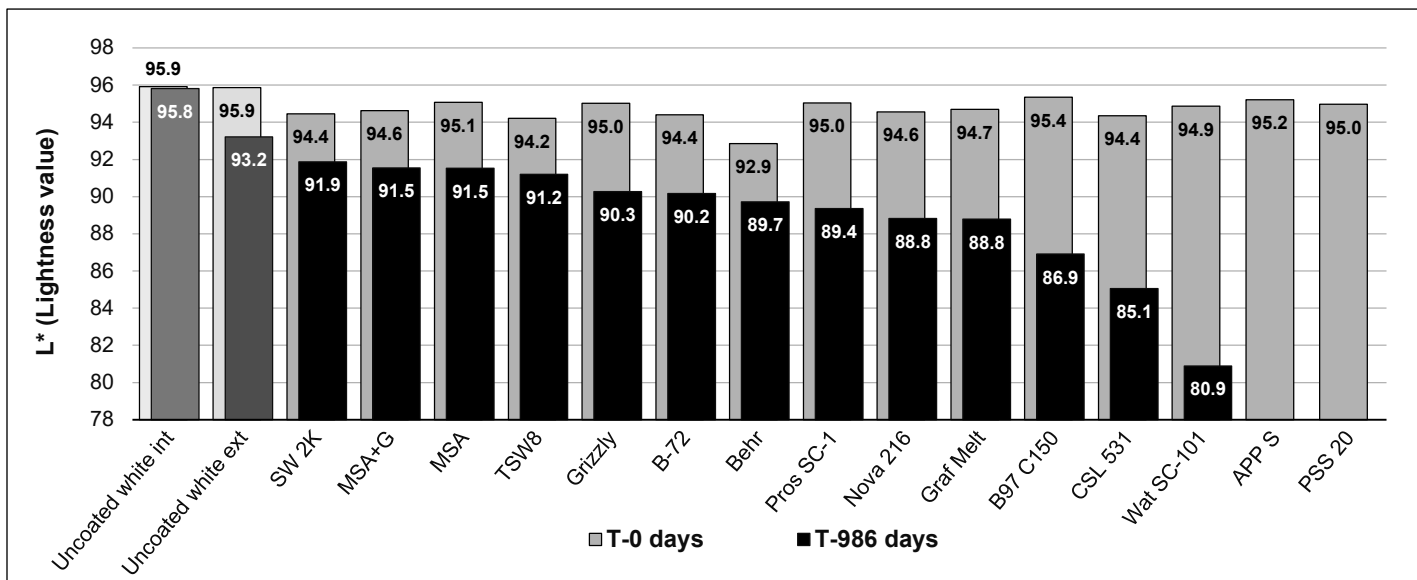
Figure 4. Change in lightness (L\*) after 3 years (986 days) of outdoor ageing ranked from smallest to largest.

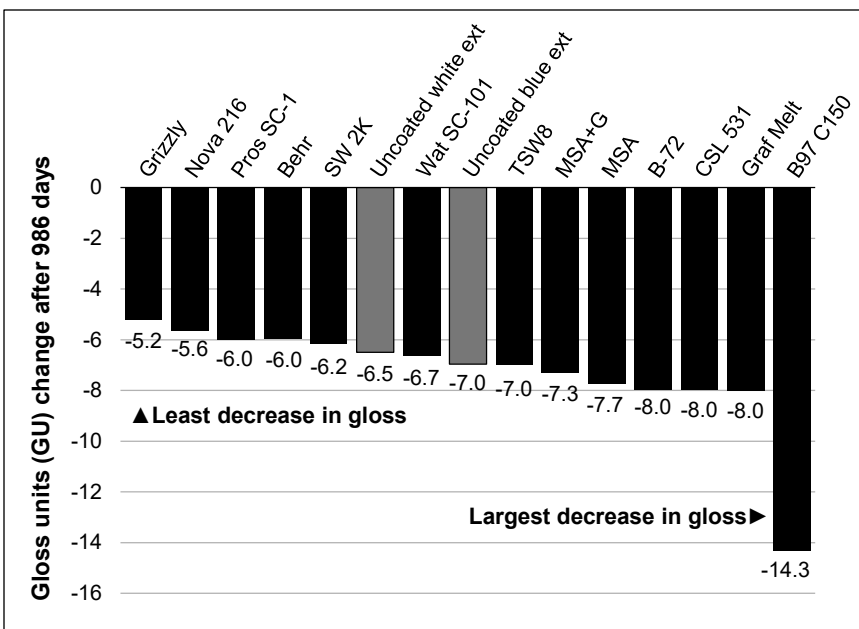
**Figure 6.** Decrease in gloss after 3 years (986 days) of outdoor ageing ranked from smallest to largest.

**Figure 6** shows the changes in gloss after three years of outdoor ageing. All coatings decreased in gloss with time. The coatings with the least amount of gloss change were Grizzly (temporary coating), Nova Color 216 (permanent coating), Behr (permanent coating) and SW 2K (permanent coating). These all fell within  $\pm 1$  Gloss Unit. The largest gloss decrease was seen with the Sherwin-Williams B97C150 (temporary coating), nearly triple the amount seen for the Grizzly. Other coatings showed small changes that, while measurable, were not easily apparent to the naked eye. However, the difference

in gloss change measured for Grizzly as compared to the silicone coating SW B97 C150 (about 9 Gloss Units) was readily visible. Good performance here is indicated by the coatings that showed the least gloss change, those that were less affected by outdoor weathering. Those that showed the greatest decrease in gloss became dulled from weathering or dirt pickup, a less desirable result. Changes observed in colour and gloss are less critical for the temporary coatings, since by definition they are routinely removed and replaced.

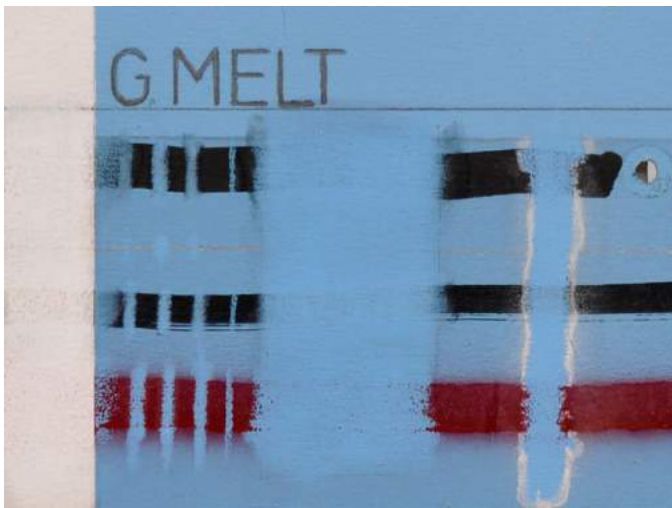
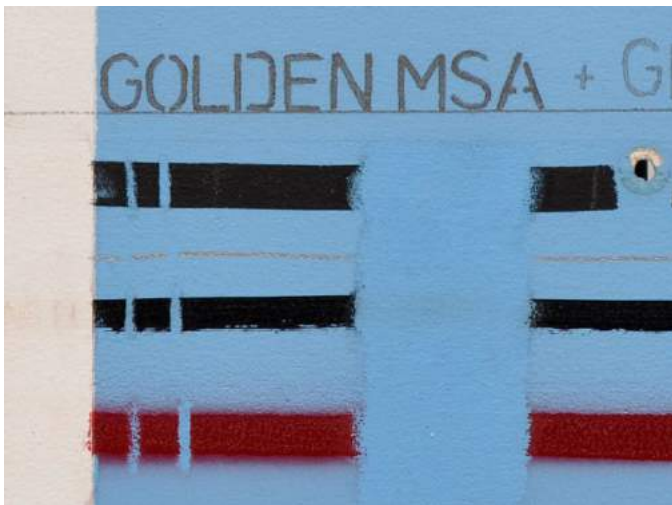
Graffiti Melt temporary anti-graffiti coating (6 layers)

Prosoco SC-1 temporary anti-graffiti coating (6 layers)

Golden MSA permanent varnish (3 layers)  
with Soft Gel undercoat (1 layer)

TSW8 permanent anti-graffiti coating (4 layers)

Nova Color 216 permanent exterior varnish (3 layers)

SW 2K permanent anti-graffiti coating (2 layers)

**Figure 7.** Some representative results after solvent and/or steam cleaning in 2015. Small initial solvent tests are shown as narrow vertical lines. The best results among the permanent coatings were achieved with the Golden MSA varnish with a Soft Gel undercoat, but most of the acrylic coatings offered substantial graffiti protection. Somewhat more graffiti residues remained on the Nova Color 216 varnish, the SW 2K and the TSW8 coatings. Most of the temporary coatings also provided very good protection, with the Prosoco SC-1 as the best performer overall.

The nature of the coating beneath the graffiti may significantly affect the solvent action during graffiti removal. For example, the solvent mixtures used in this study did not perform equally well on all the acrylic coatings. The Nova Color 216 varnish is based on a harder acrylic resin than others examined in this study.<sup>7</sup> This is likely due to the relatively elevated glass transition temperatures of its constituent copolymers. This varnish seemed to somewhat resist the solvents, which caused some redeposition of the black graffiti into the surface of the varnish, especially visible on the area of white paint (**Figure 7**). An alternate solvent choice or cleaning system may have fared better here.

Of the two similar aqueous wax-based emulsions, Graffiti Melt and Prosoco SC-1, the latter was the slightly better performer over time, since it appeared brighter and less greyed than the Graffiti Melt. While visually there was no discernible difference between three and six coats, the Graffiti Melt better protected the underlying paint when six spray coats were applied. The recommended minimum number of coats (3) was thus seen to be less effective in providing protection. The application of hot water vapour worked immediately to reduce or remove graffiti on both the Prosoco SC-1 and Graffiti Melt coatings, but localized hot vapour cleaning left a blanched, whitish ring in the coating around the perimeter of the cleaned areas (**Figure 7**). These blanched areas can be partially reduced by solvents and by reapplying more of the coating. Both coatings have the advantage that overlying graffiti marks can sometimes be mechanically reduced and scraped away. The addition of mechanical cleaning and polar solvents was needed to achieve complete removal of the graffiti for both coatings. Both coatings could benefit from periodic surface cleaning to remove imbibed dirt, and both products have a serviceable life of at least five years, possibly more.
