Marcelle Ferron for Conservators: The Artist, her Materials and Techniques from 1953 to 1960, and the Treatment of an Untitled Oil Painting on Canvas and Plywood

Marie-Catherine Cyr and Wendy Baker

Journal of the Canadian Association for Conservation (J. CAC), Volume 35 © Canadian Association for Conservation, 2010

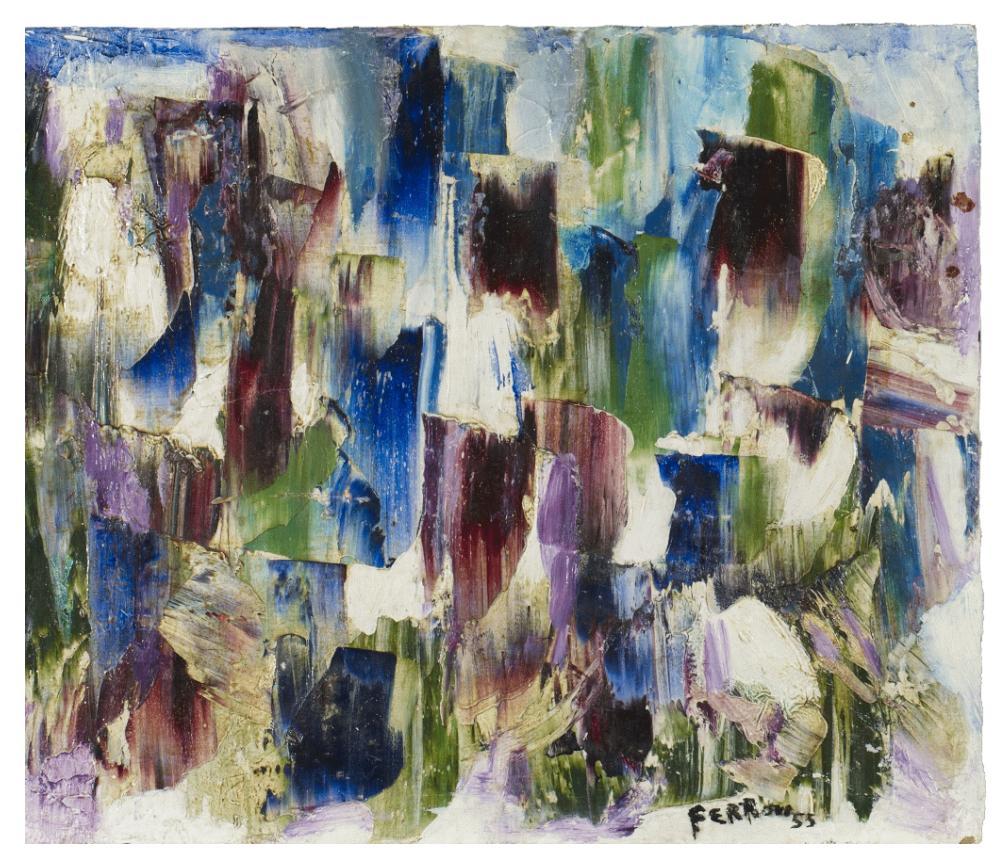
Figure 1. Marcelle Ferron, *Untitled* (1955), Before Treatment. Firestone Collection of Canadian Art, The Ottawa Art Gallery; Donated to the City of Ottawa by the Ontario Heritage Foundation. Photo: Carl Bigras, CCI. © Marcelle Ferron Estate/SODRAC (2010).

The painting is shown in **Figure 1** as it appeared before treatment at CCI with the painted canvas adhered, by the artist, to a plywood backing. Based on existing visual evidence, Ferron likely prepared the painting in the following manner. A canvas was first stretched and tacked onto a temporary auxiliary support (stretcher or strainer) and was prepared with a ground layer and painted. The artist laid the colours in thick and rapid successive applications, wet on wet, layer upon layer, using palette knives. This painting may have been created on a recycled painted canvas, or its composition changed, as colours foreign to the final painting, such as bright orange and pink, could be seen through losses in the *impasto* close to the edges. However, an underlying

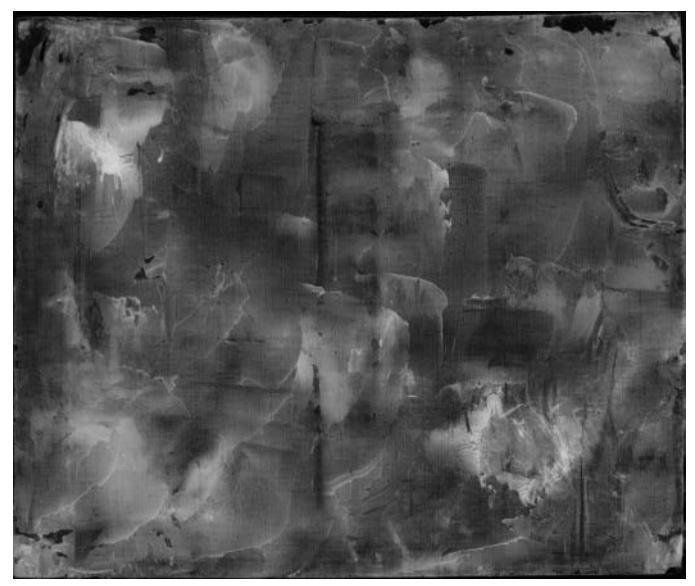
Figure 4. X-radiograph composite of *Untitled* (1955), BT. Photo: Jeremy Powel and Carl Bigras, CCI.

An X-radiograph of this painting (Figure 4) shows that the original support had a 4.5 cm-wide vertical cross-bar. There is a clearly delineated vertical band where the initial ground application and paint were thinner, this being an area where the artist's knife would have met resistance. Although the X-radiograph showed faint stretcher garlands around the perimeter, there is no distinct outline of the stretcher's outer members. There are several possible reasons for the absence of stretcher bar marks in this region, one of which is that the original size of the painting may have been slightly larger than the current presentation, and the edges cropped back. Another possibility is that greater pressure was applied to the centre of the canvas when forming full knife strokes and the paint there is therefore thinner than it is along the perimeter where the hand generally tends to lift away from the canvas before going over the edge.

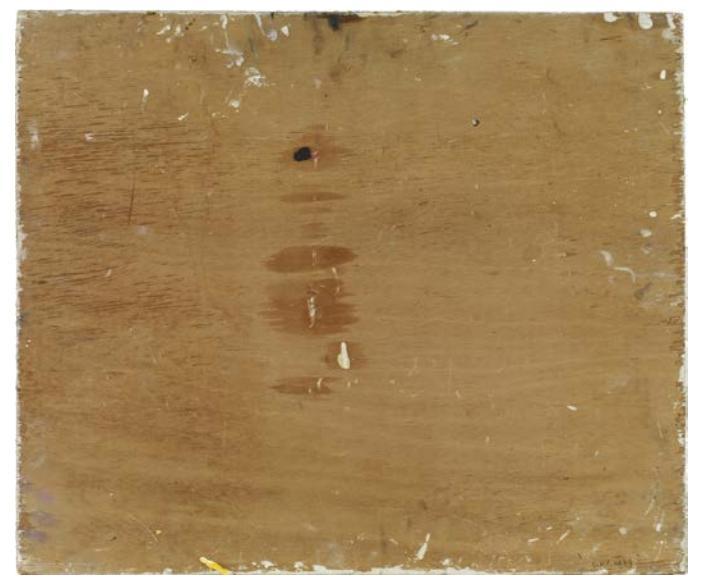
After having laid out the initial scheme of the painting, Ferron cut the canvas to fit its intended auxiliary support, a five-ply plywood board (**Figure 5**), adhering the painted canvas to the board using an epoxy adhesive. This epoxy

Figure 5. Untitled (1955), BT. Verso showing the plywood auxiliary support. Photo: Carl Bigras, CCI.

by display. Its appearance was also sufficiently removed from the artist's intention to cause a disservice to both the artist and the work of art. The painting had a highly yellowed surface coating, significant and unsightly deformations of the canvas, small losses, and long horizontal cracks. The plywood support was still in very good condition, with all edges painted white, and paint smudges, oil stains, and coloured imprints scattered across its *verso*, as is typical for Ferron's auxiliary supports (see **Figure 5**).

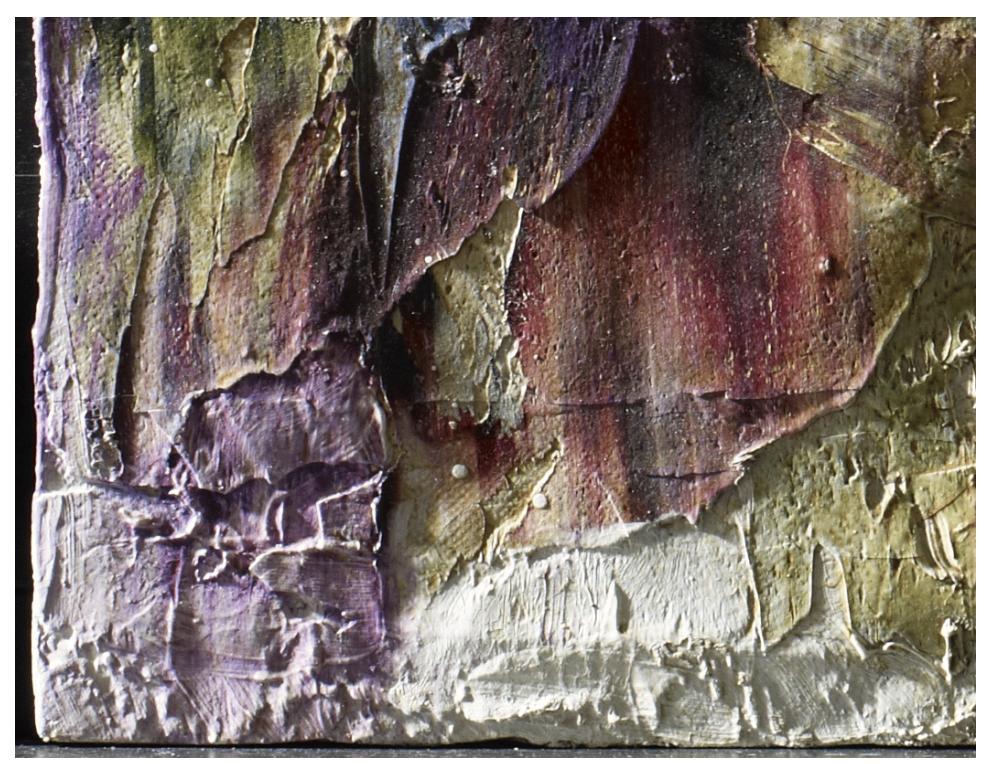
Figure 6. Untitled (1955), BT detail, bottom left corner, raking light. Rough fill material and artist brushapplication of purple and white paint over cut edges. Photo: Carl Bigras, CCI. © Marcelle Ferron Estate/SODRAC (2010).

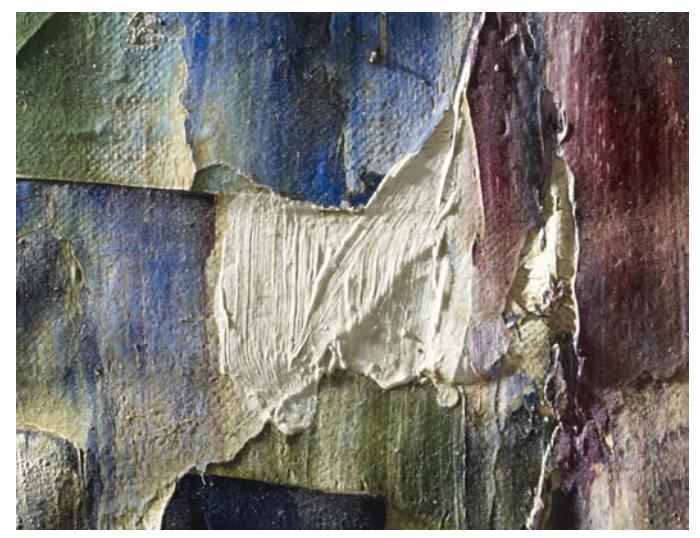
Figure 7. *Untitled* (1955), BT detail, raking light. Artist brush-applied retouch to brighten a white area. Photo: Carl Bigras, CCI.

The fact that the paint layers may not have been fully cured does not seem to have prevented some cracking and loss from taking place before the painting was adhered to the plywood backing. It was assumed that the cracks had begun forming before adhesion of the canvas to the plywood, as their locations were not consistently related to areas of delamination. A number of losses were noted at or close to all the edges (seen as discrete black areas in the radiograph, Figure 4). Often of significant size (6 to 10 cm^2 on average), they had been repaired by the artist using heavy, pigment-rich inlaid paint and then retouched. They probably occurred when the artist cropped the painted canvas before adhering it to the plywood board. Only minor losses were evident within the painting field and these were restricted to edges of impasto. There were two fairly significant cracks (7 and 11 cm long) through the paint and ground layers, with slightly overlapped edges; these ran horizontally across the painting (Figure 13). Retouches were carried out by the artist to those areas of white paint that she deemed in need of highlighting or brightening (see Figures 7 and 8).

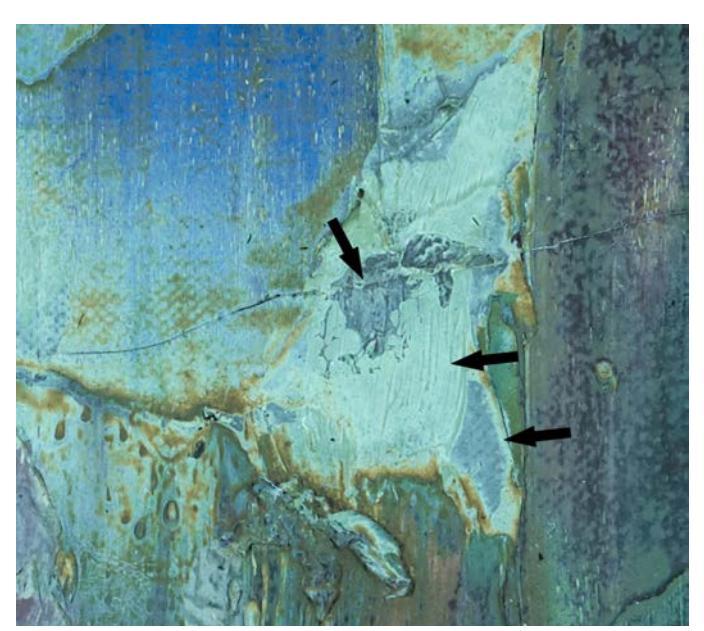
damages to the paint and ground layers incurred from the cropping of the canvas along the edges of the painting. These initial repairs, and possibly subsequent repairs by the artist, can be seen in three of the four corners, where a textured material forms the support for the missing white paint and for the other paint colours (Figure 6). Ferron also reworked and retouched the painting at some time, using a brush instead of knives. Lighter colours were added to the composition, and losses and cracks were painted over (Figure 7). Examination under ultraviolet light and under magnification revealed three retouching campaigns by the artist, in the whites. At least one of these occurred after the painting was coated by the artist with a dammar varnish (Figure 8).

Figure 8. Untitled (1955), BT detail. Ultraviolet light reveals three campaigns of white retouching to a paint loss and part of a crack. Under normal light this appears as one white retouch. Photo: Carl Bigras, CCI.

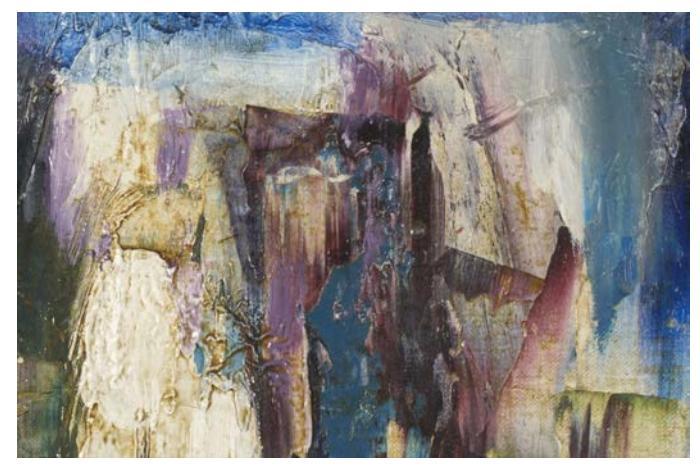
Figure 9. Untitled (1955), BT detail, top left corner. Discoloured coating and areas of pooling in wrinkles and creases. Photo: Carl Bigras, CCI.

The degraded surface coating was of irregular thickness: very thin and translucent in some areas, while quite thick and opaque in others (**Figure 9**). Where it was applied thickly or had pooled, especially in deep wrinkles, creases and other depressions in the paint, the coating obscured the rich bright colours. All evidence indicated an original and artistapplied varnish, as surface dirt and some of the small deposits of epoxy resin and gum arabic (likely accidental spatters by the artist) were located above the varnish

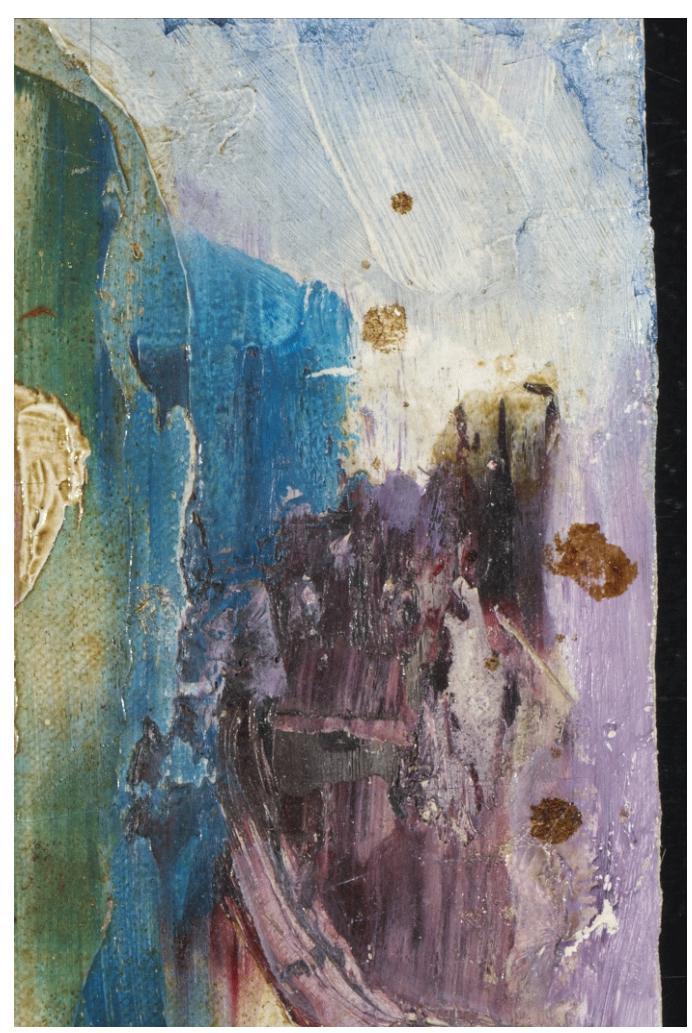
Figure 10. Untitled (1955), BT detail, top right corner. Deposits of discoloured gum arabic. Photo: Carl Bigras, CCI.

layer. Accretions contributed to the surface discoloration, having become more visible as they aged (Figure 10).

Following consolidation, the surface was cleaned using an aqueous solution prepared according to Chris Stavroudis' Modular Cleaning Program.⁴³A 2:1:2 solution of distilled water, pH 7.5 Tris/HCl buffer concentrate and pH 7.5 citrate/NaOH chelator concentrate, worked slightly better than saliva in this case. The brown stains (gum arabic) in the upper right corner were easily removed with distilled water.

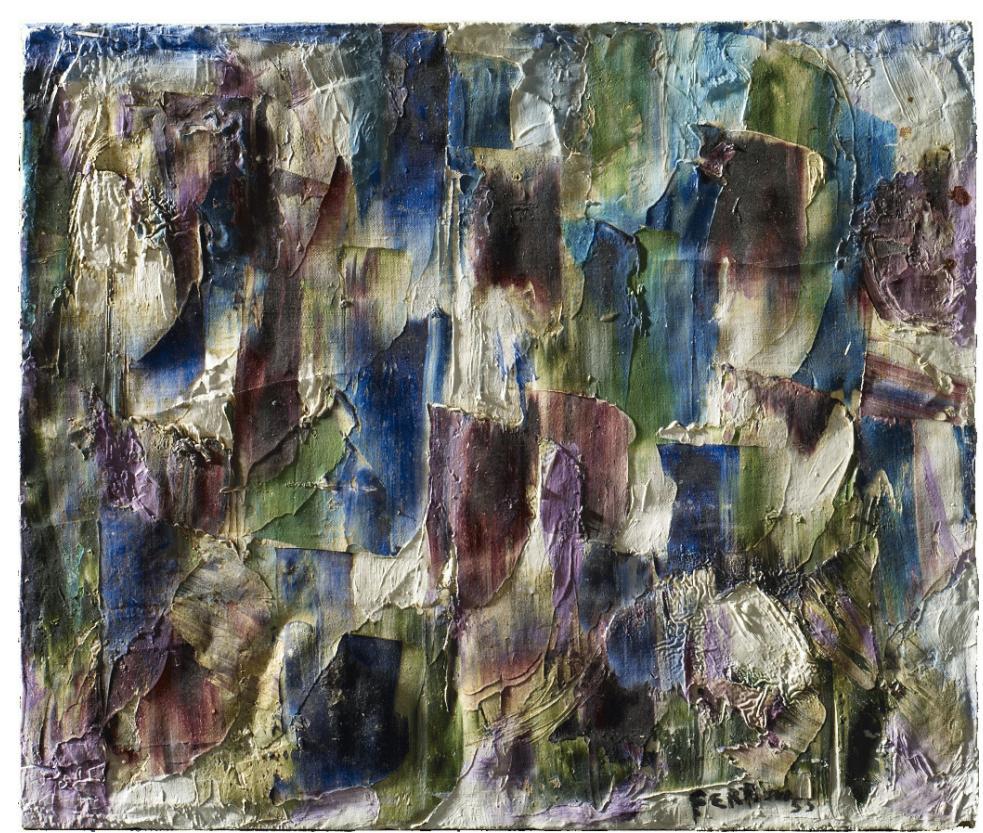
Figure 11. Untitled (1955), BT raking light. Surface appears "wavy" due to the many rounded deformations of the canvas support. Photo: Carl Bigras, CCI.

The presence of very noticeable dome-like deformations of the canvas gave the painting a "wavy" appearance (**Figures 11** and

12). These deformations varied in size, ranging from 3 to 9 cm in diameter and 0.1 to 0.5 cm in height. Generally, the edges of the canvas were fairly well secured to the auxiliary support, and the delaminations and subsequent swelling of the canvas had taken place inside the borders of the work. Some of the raised areas were hard to the touch, this being the result of the heavy paint layers and possibly a thin layer of epoxy adhesive hardened on the reverse side of the canvas. The extensive delamination between the canvas and plywood was found, by light tapping of the surface, to cover about half of the total area of the painting. Given the irregular configuration of extruded adhesive visible along the top edge of the painting between the canvas and plywood support (Figure 12), the adhesive was applied quickly and irregularly. This observation has also been made by others familiar with similarly mounted paintings by Ferron.³⁸ Not only would an irregular application of epoxy be conducive to adhesive failure, but adhesive failure may have been exacerbated by undulations or quilting of the painted canvas that would have developed prior to the canvas application to the plywood. These areas would not have adhered to the plywood backing, and would subsequently have been free to move over time, forming the large "bubbles" of painted canvas visible on the surface of the painting.

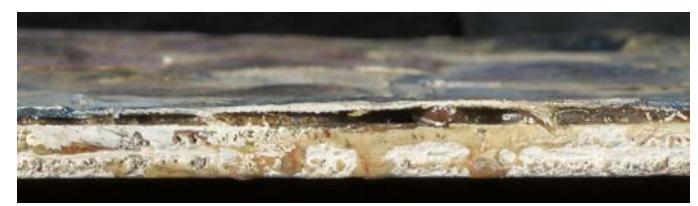
Figure 12. Untitled (1955), BT, top edge. Side-view of the plywood/canvas interface showing the epoxy adhesive, gaps and canvas deformations. Note the white paint along the edge indicating artist reworking after the painting was adhered to the plywood. Photo: Carl Bigras, CCI.

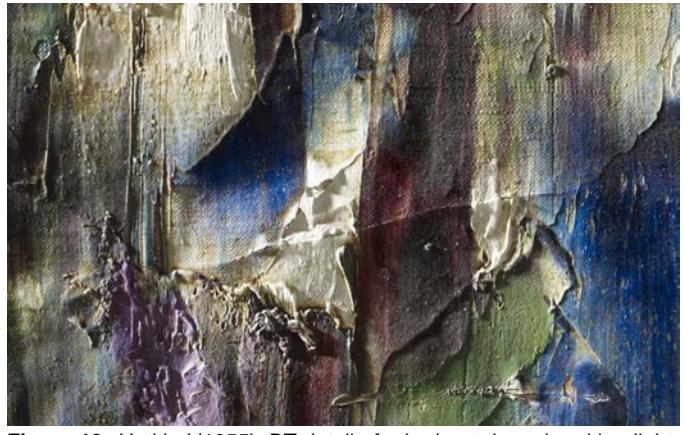
Figure 13. *Untitled* (1955), BT detail of a horizontal crack, raking light. Note the slightly overlapping edges, paint losses and white artist-applied retouches. This image is an enlarged view of the area shown in **Figure 8**. Photo: Carl Bigras, CCI.

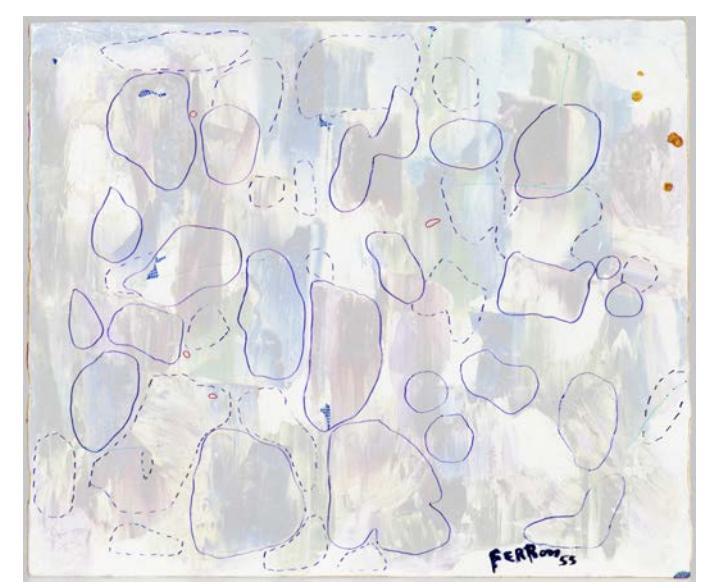
Figure 14. *Untitled* (1955), BT, superimposed with the delamination map. Continuous lines indicate areas of delamination associated with a canvas deformation, dotted lines indicate delamination without deformation. Photo: Carl Bigras, CCI.

Areas of delamination, as well as all accretions, losses, cracks and deformations were carefully mapped out on a Mylar overlay, which will hereafter be referred to as the delamination map (**Figure 14**).

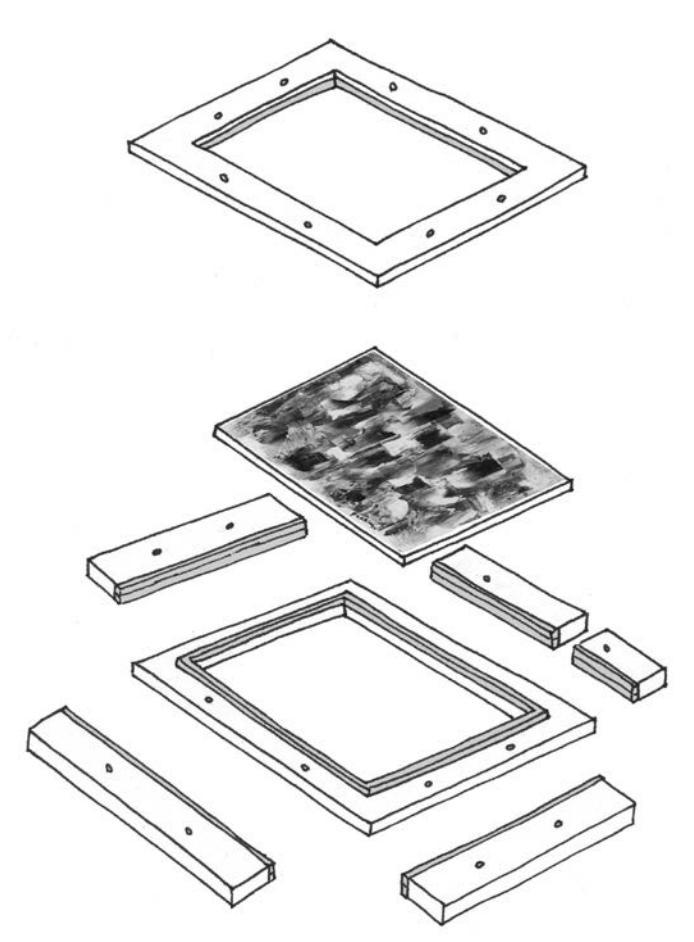
Figure 15. Handling frame component diagram, showing all parts in their layered structure before assembling.

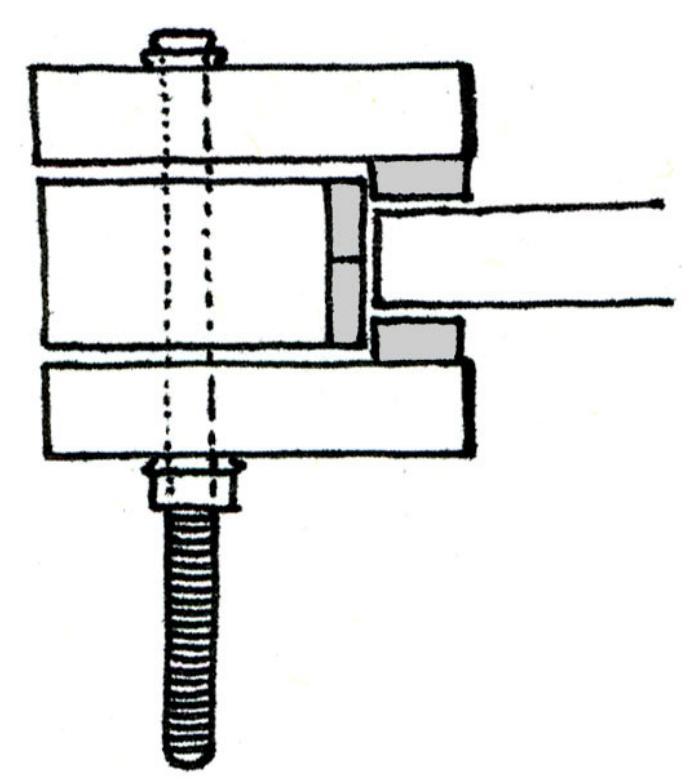
Figure 16. Handling frame construction diagram, showing a cross-section of the layered structure and assembly. The Coroplast layers were spaced for the purpose of clarity in this diagram.

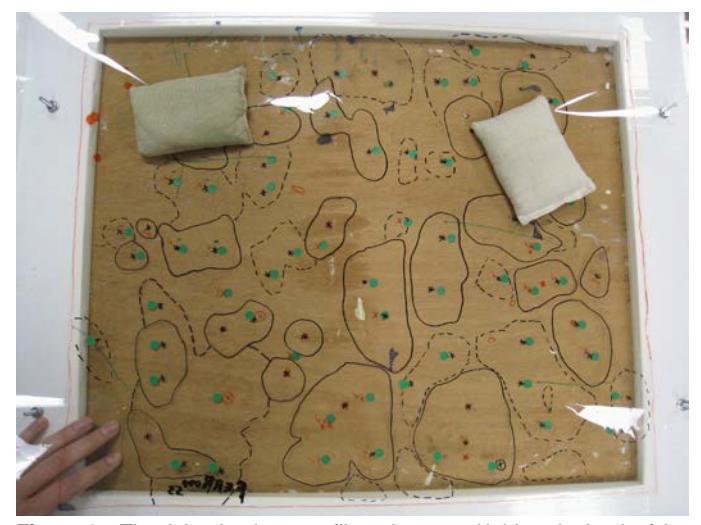
Figure 17. The delamination map flipped over and laid on the back of the painting. Optimal hole location markings, according to delamination zones and predicted adhesive flow patterns, were transferred onto the plywood with a graphite pencil.

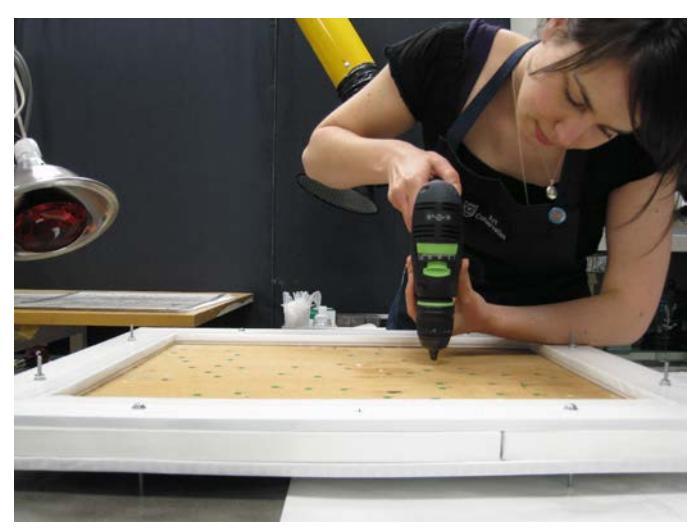
Figure 18. Drilling into the back of the plywood board. The painting is secured in its handling frame and the drill bit is set at a length of 0.9 cm, the thickness of the board.

pressed onto the board during the moisture/heat treatment. A 0.965 mm diameter drill bit was selected to produce the holes. During the drilling operation, holes were drilled through the plywood one area at a time, as situated by the Mylar overlay delamination map. Optimal adhesive entrance points were indicated on the map, and these markings were transferred to the back of the plywood with a pencil (Figure 17). The length of the drill bit was set to exactly 0.9 cm, which was the thickness of the plywood board, so that there was no chance of drilling too deeply and piercing the canvas (Figure 18). It was also necessary to avoid creating a burr at the exit hole or to push wood dust between the canvas and the plywood, effectively trapping debris. Much testing with different drill bits was undertaken in order to circumvent these problems. In the end, it was the process rather than the tool that made the difference. In order to avoid pushing wood dust out the hole at the canvas/board interface, the drill was pulled out of the hole two or three times while drilling, before boring the exit hole, taking almost all of the dust out the back and reducing the burr to a minimum. To verify that the

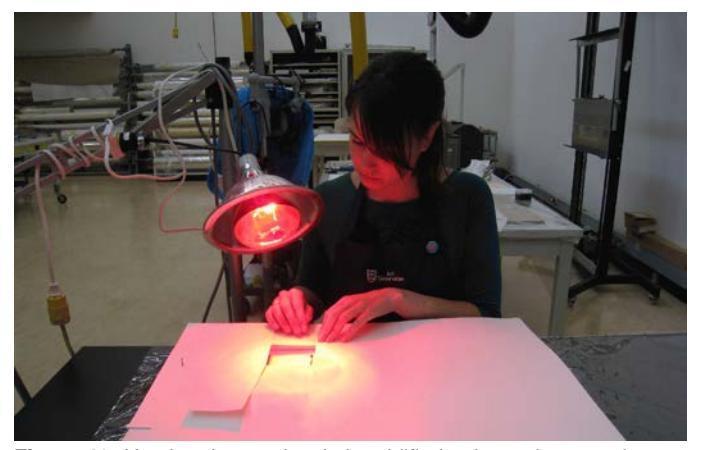
Figure 19. Heating the previously humidified paint and canvas layers. The exposed area receives heat for no more than three minutes at once and the heat treatment is repeated until the paint and canvas are flexible and can be brought in contact with the plywood with slight finger pressure.

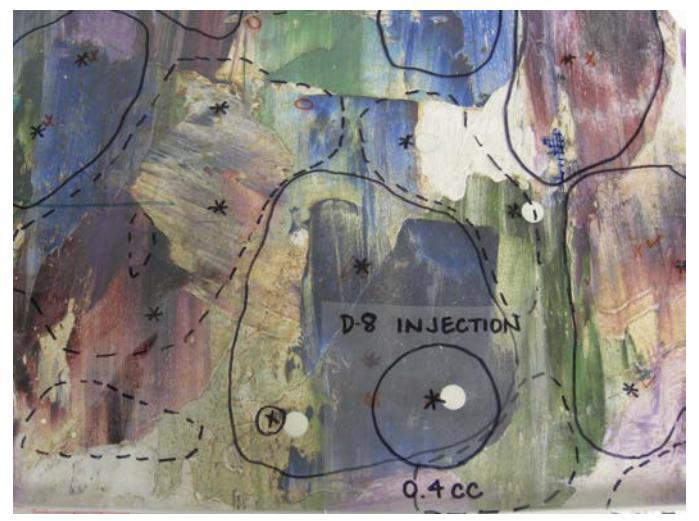
Figure 20. The delamination map is overlaid on the recto of the painting. The injection template, a circle marked at 0.4 cc, is placed over the various marked hole locations (*) to estimate the quantity of adhesive to inject in each hole to re-adhere that area of delamination.

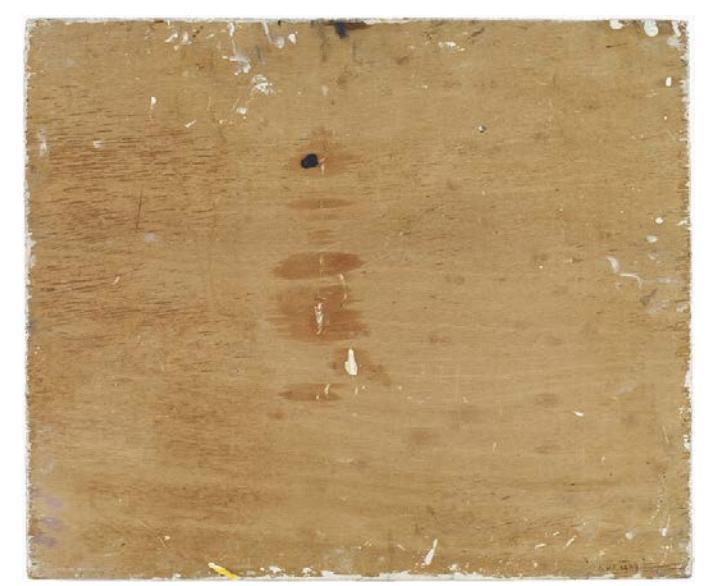
Figure 21. Untitled (1955) verso, after treatment. Photo: Mylène Choquette, CCI.

applied through silicone-release Mylar to assist in the distribution of adhesive between canvas and plywood. The movement of the adhesive in the interface could be felt and the readhered area determined. The presence of a layer of moisture (from the adhesive) behind the canvas combined with additional heating from an IR lamp during this process helped to further relax the paint and canvas layers back to the plywood. Once no more movement of adhesive could be felt, the painting, in the handling frame, was turned over and the wax plug removed to speed drying. Face up again, the treated zone was left under weights for about 15 hours. This sequence was repeated for each drilled hole, working one hole at a time, although up to four holes in one area could be done in one day and left under weight overnight. Once this adhesive treatment was complete, all of the many drill holes were sealed with Multiwax W-445. This is a white, high molecular weight microcrystalline petroleum wax with excellent resistance to ultraviolet (UV) and colour stability. It has a high melting point (76-80°C), is hard, flexible and has excellent adhesive properties. This material can be excavated and removed from the drill holes, if required. The appearance of the plywood back remained virtually unchanged, and the drill holes were only visible upon close inspection (Figure 21).

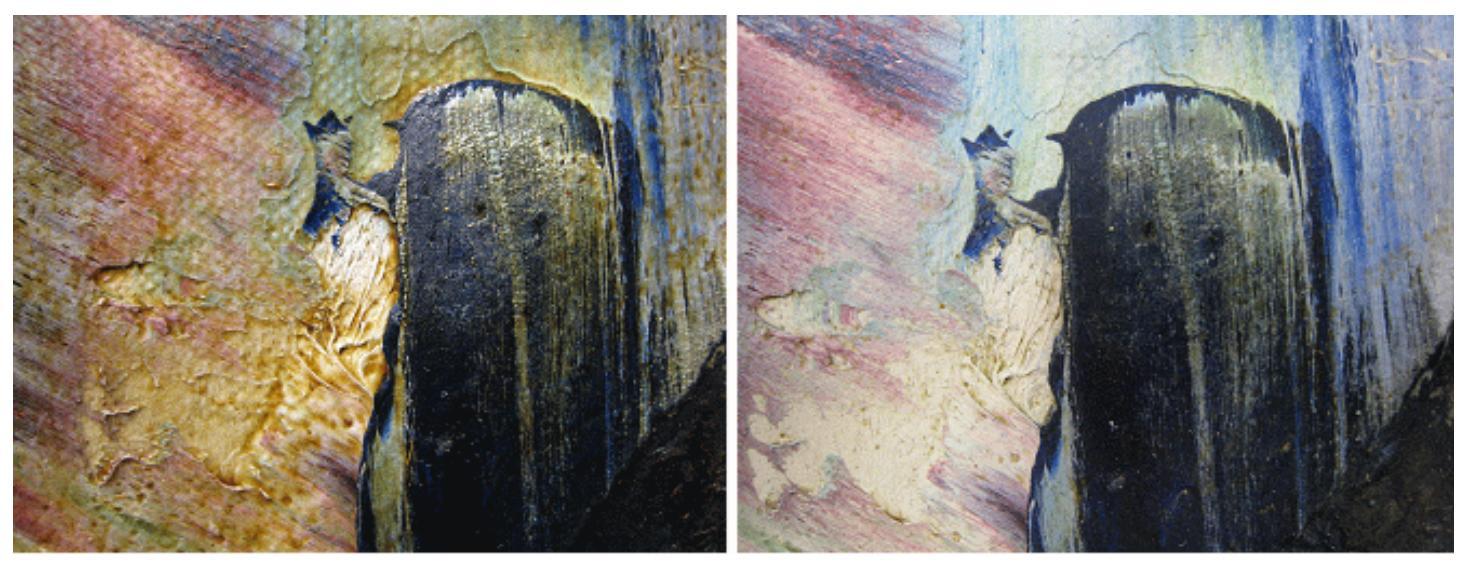
Figure 22. Untitled (1955), details, before (left) and after (right) varnish removal. The 100% solvent gel mixture was used throughout this area, except on the blue, where the use of 50% was necessary. Thicker varnish layers around the contour of the blue impasto were removed mechanically.

The decision was made to remove the discoloured coating, an original dammar varnish with traces of beeswax. The coating had marred the surface of the work and the artist herself was known to have been open to the removal and replacement of her surface coatings when this was required.³⁶ Given the highly textured surface of the painting and the varying sensitivities of the paints, solvent gels were used to gain better control over the varnish removal process. A 4:1 xylene/isopropanol gel was most effective, although some of the colours demonstrated sensitivity to this. In order to address these areas, a second gel was mixed to obtain a 50% dilution of the first gel in mineral spirits.⁴⁶ The gel was wiped off with a dry cotton swab and the area rinsed with a 4:1 mixture of mineral spirits and isopropanol. Thicker varnish, located in wrinkles, creases and air bubble holes, that was either difficult to access or to dissolve with the solvent gels, was mechanically removed with fine pointed tweezers and the tips of bamboo skewers. Figure 22 shows details of the painted surface before and after varnish removal. A few thin areas of the original coating were left untouched as they were underneath highly soluble retouches applied by the artist. Where the yellowed varnish showed through these translucent retouches, the discoloration was broken up by the application of small dots of watercolour to restore visual continuity.

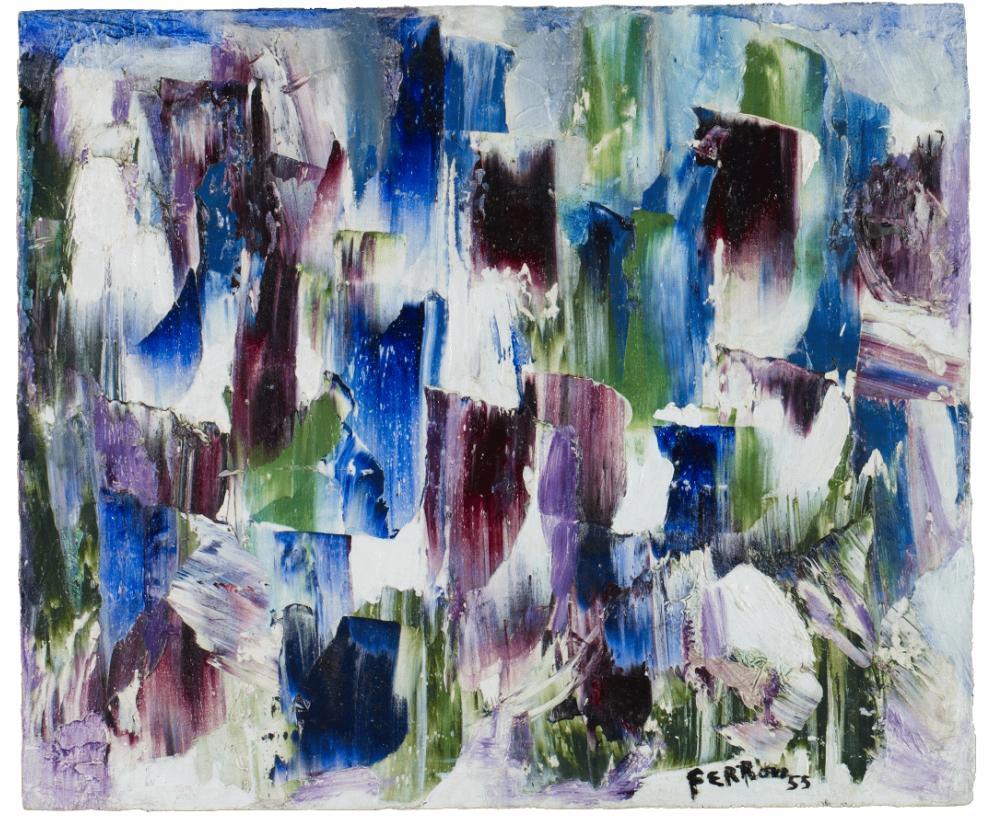
Figure 23. Marcelle Ferron, *Untitled* (1955), After Treatment. Firestone Collection of Canadian Art, The Ottawa Art Gallery; Donated to the City of Ottawa by the Ontario Heritage Foundation. Photo: Mylène Choquette, CCI. ©Marcelle Ferron Estate/SODRAC (Montreal) (2010).
